## ENGINEERING REPORT

**November 12, 2025**

**RE: Construction Defect Assessment  
City of Fayetteville  
Fayetteville Fire Department New Sub-Station No. 4  
4210 Bragg Boulevard  
Fayetteville, North Carolina 28303  
ABS File Number: 900.25030**

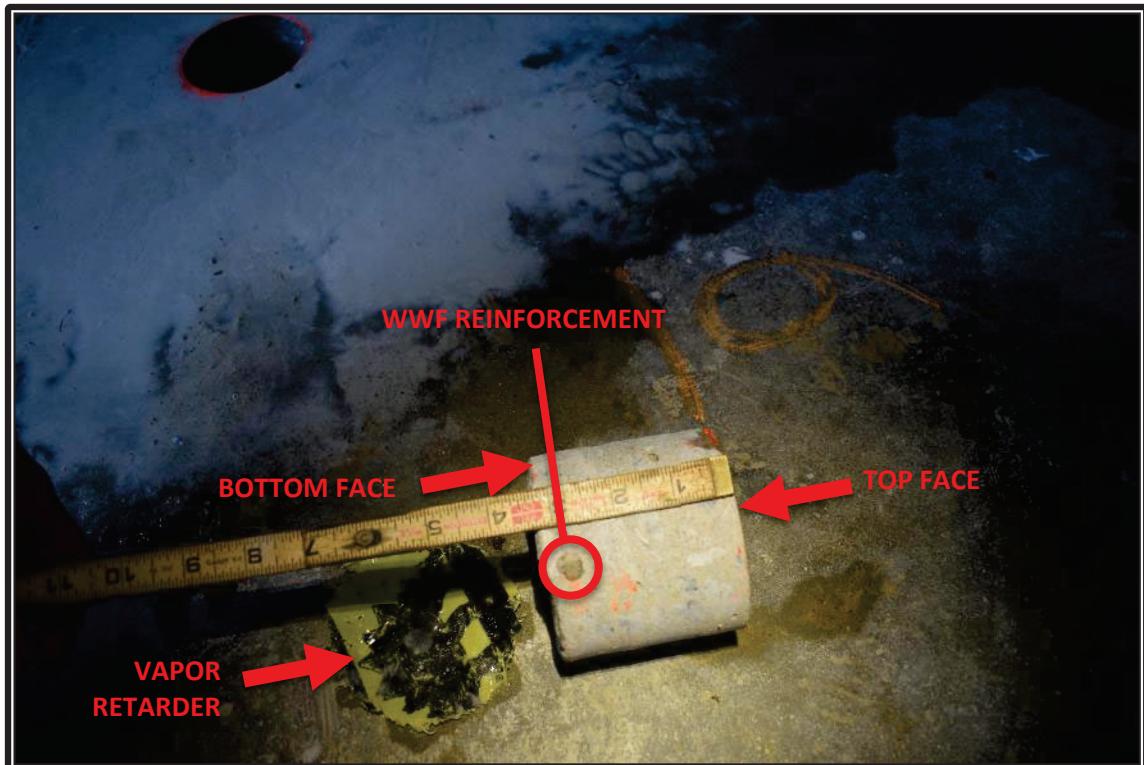
2. At each of the core drilling locations, a 10-mil vapor retarder was observed at the underside of the concrete slab above the stone base.
3. WWF was observed within each of the six (6) cores. Measured from the bottom of the slab core, the cover of the wire at three (3) of the cores measured approximately 1 inch; at the three (3) remaining cores, the cover of the wire measured approximately 1.25 inches, 0.75 inches, and 0.5 inches. The 4-inch diameter concrete cores each intersected one (1) parallel wire, indicating that the spacing of the welded wire fabric exceeded 4 inches. The specified WWF spacing was 6 inches.

**Photo 4:** View of concrete core measuring approximately 3.25 inches in depth, the location of a WWF wire, and vapor retarder.

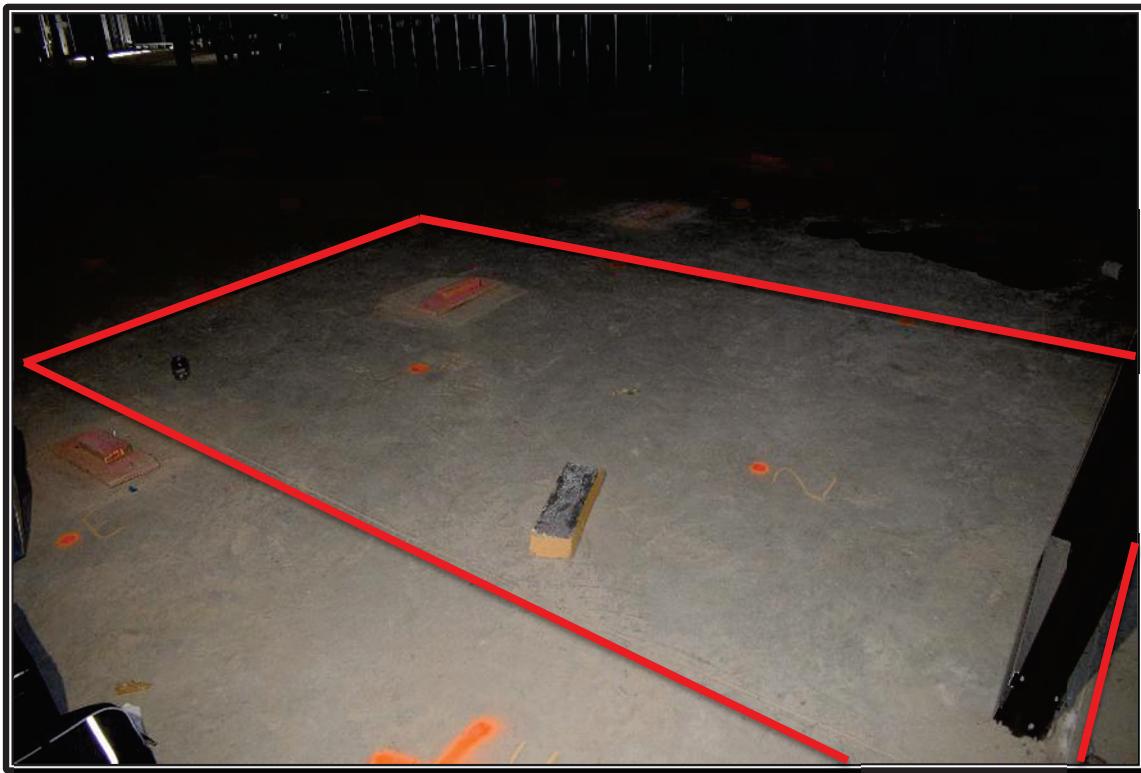
8. The sawcut control joints observed throughout the living area slab-on-ground were generally spaced at approximately 10 to 15 feet in both directions; however, the spacing of the joints varied in some areas.
9. In at least one (1) location, the length of the control joint panel was approximately double the width of the panel, resulting in an aspect ratio of approximately 2 to 1 (**Photo 5**).

The plans (Sheet 3.01) provide a detail for the construction of control joints in the slabs, but do not specify the location or spacing of the control joints. According to the "Construction Joint Layout" submittal, comments from T&V indicate that the maximum control joint spacing for the living area 4-inch slab-on-ground is 16 feet. According to ACI 360R-10 Section 6.1.3, the recommended control joint (referred to as a contraction joint in ACI 360R-10) spacing for a 4-inch typical concrete slab is approximately 11 feet; it also specifies that the maximum aspect ratio of any panel should be 1.5 to 1 and that L- and T-shaped panels should be avoided. It is ABS' opinion that the living area slab-on-ground control joints are generally spaced in accordance with the "Control Joint Layout" submittal and ACI 360R-10, but that some control joint panels exceed the limiting 1.5 to 1 aspect ratio specified in ACI 360R-10.

**Photo 5:** Representative view of a control joint panel with an aspect ratio of approximately 2 to 1 (outlined).

**ABS Recommendation:** It is ABS' opinion that areas of the interior concrete slab-on-ground that do not meet these requirements should be removed and replaced or modified to meet the requirements.

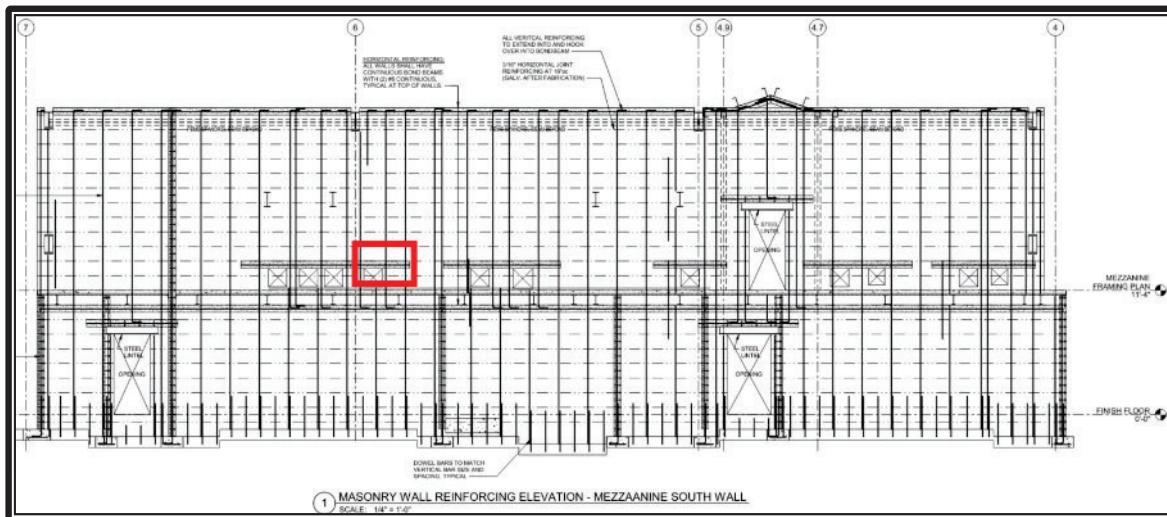
Test Area 1 was located at the full-height mezzanine wall within the living area and was tested from the south face of the wall (**Figure 4**). The plans (Sheet 3.59) indicate that Test Area 1 should have included a bond beam at the top of the adjacent series of openings, jamb reinforcement at each opening, and typical wall reinforcement. Note that RFI #53 indicates that within the area below the HVAC openings at Test Area 1, cells should be fully grouted.

**Figure 4:** CMU wall elevation showing the approximate location of Test Area 1 (outlined) (cropped plan courtesy of T&V).

10. The openings at Test Area 1 were positioned such that the top of the openings were located midway through a CMU course. As a result, it appeared that the bond beam at Test Area 1 was constructed above the partial CMU course. Other openings within the same wall were located with the top of the opening level with the top of a full CMU course.
11. At the bond beam above the openings, cells appeared to contain reinforcement and be grouted.

Below the openings, fully grouted cells with no continuous reinforcement were observed, which was consistent with RFI #53. RFI #53 indicates that the areas below the openings do not require reinforcement but must be solid-grouted.

**ABS Recommendation:** Because of the extent of improperly constructed CMU walls identified in F&R's March 11, 2024, letter and/or during ABS' site visit, including at multiple critical structural components, it is ABS' opinion that the interior and exterior CMU walls should be removed and reconstructed.

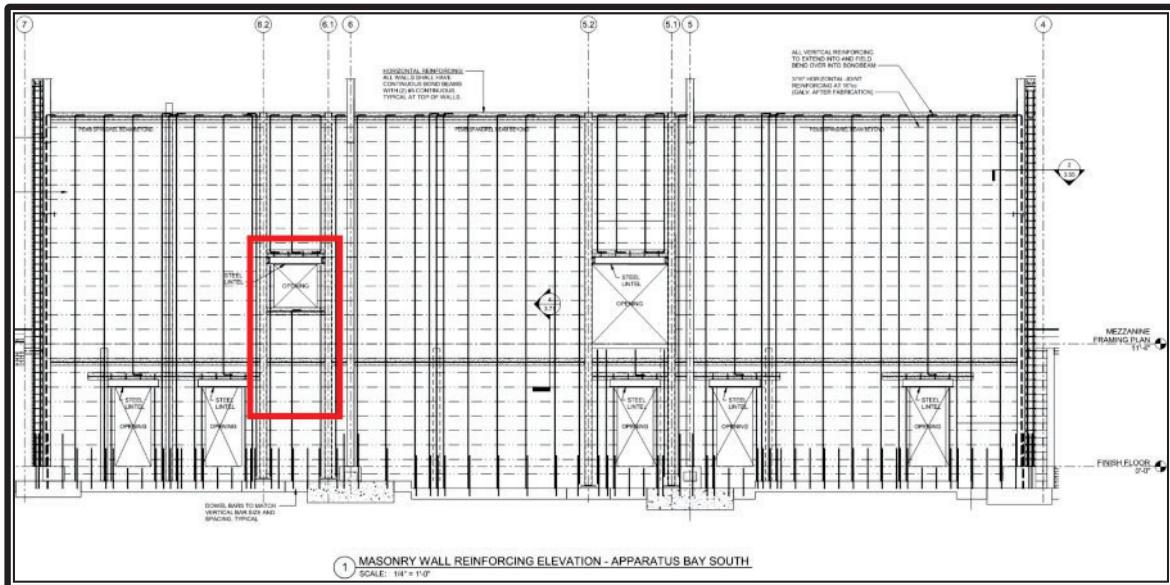
**Figure 5:** CMU wall elevation showing the approximate location of Test Area 2 (outlined) (cropped plan courtesy of T&V).

15. The bond beams located at the top and bottom of the opening did not appear to contain reinforcement and/or be fully grouted.
16. At the bottom bond beam, a cell without grout or reinforcement was visually observed from the sill of the opening.
17. At the top bond beam, the cells at the head of the opening above the steel lintel were exposed. Visual observation indicated that the cells were at least partially filled with debris. Holes drilled into the cells indicated that the cells were partially grout-filled above the debris.
18. Grout and reinforcement observed immediately below the opening were consistent with expected typical wall reinforcement.

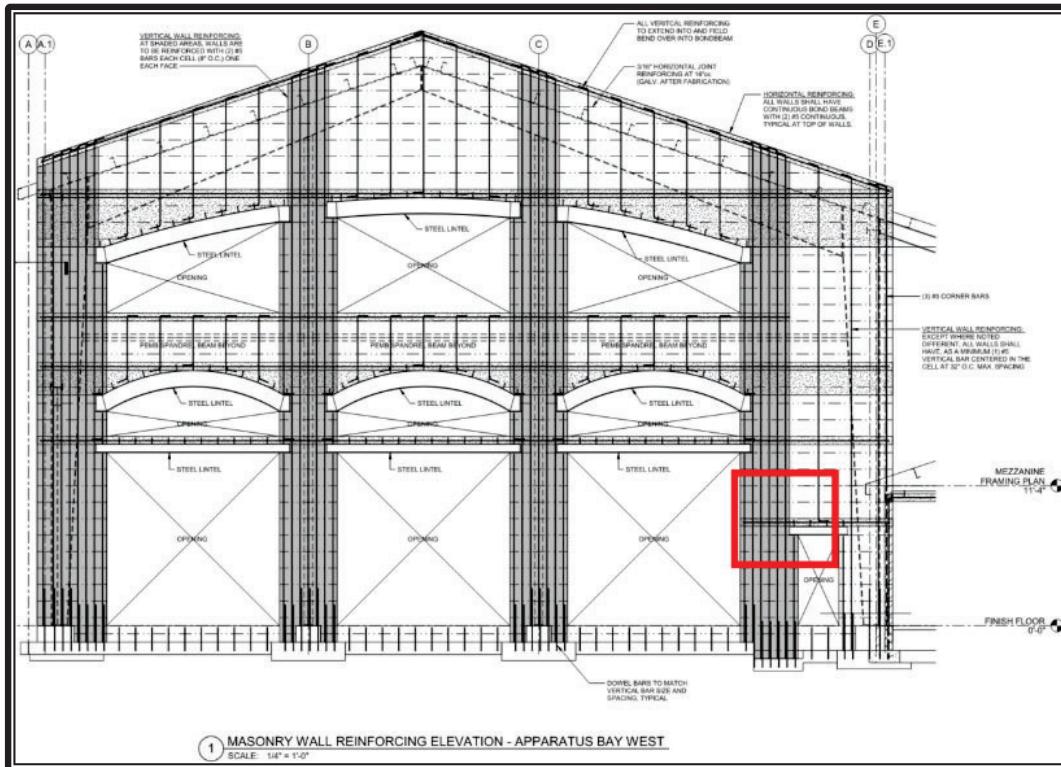
Test Area 3 was located at the west apparatus bay wall and was tested from the east face of the wall (**Figure 6**). The plans (Sheet 3.56) indicate that Test Area 3 should have included a bond beam at the top of the adjacent opening, jamb and bearing reinforcement at each opening, reinforcement along the control joint (not shown on the plans), and typical wall reinforcement.

**Figure 6:** CMU wall elevation showing the approximate location of Test Area 3 (outlined) (cropped plan courtesy of T&V).

19. The bond beam located at the top of the adjacent opening appeared to contain reinforcement and be grouted. It appears that the bond beam reinforcement ends at the control joint located adjacent to the opening.
20. The cells along the opening's jamb and bearing locations appeared to contain reinforcement and be grouted.
21. The cells along either side of the control joint appeared to contain reinforcement and be grouted.
22. Grout and reinforcement observed in the field of the wall was consistent with expected typical wall reinforcement.

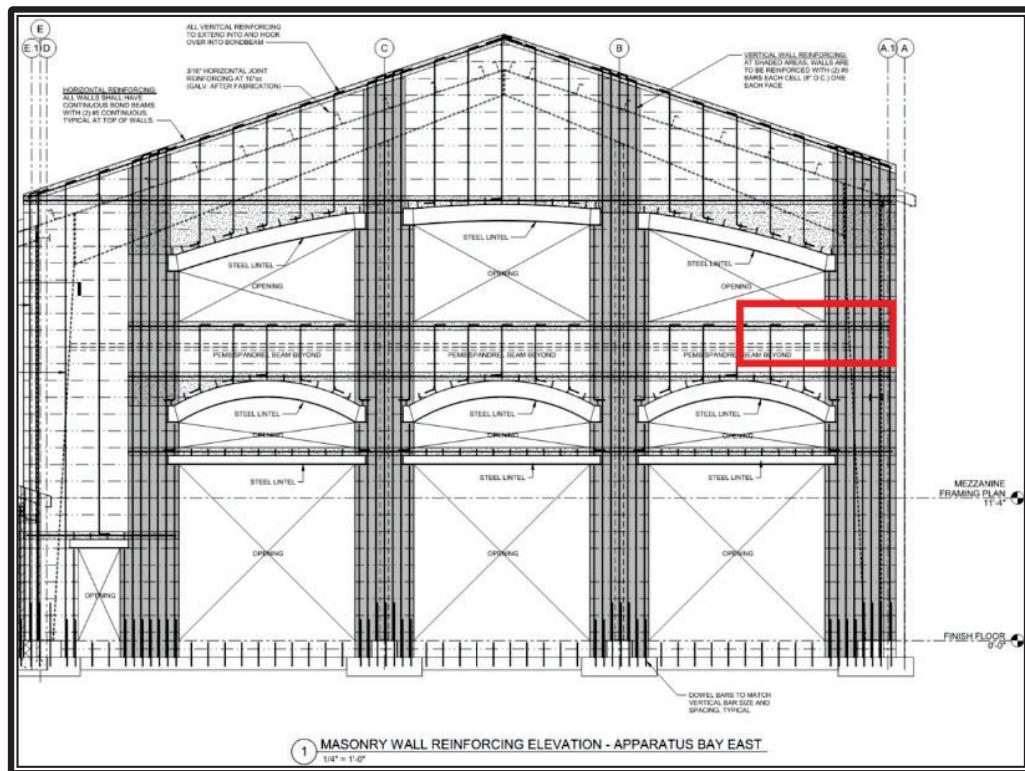
Test Area 4 was located at the east apparatus bay wall and was tested from the west face of the wall (**Figure 7**). The plans (Sheet 3.55) indicate that Test Area 4 should have included a bond beam at the bottom of the opening, jamb and bearing reinforcement at the opening, corner reinforcement, and typical wall reinforcement.

**Figure 7:** CMU wall elevation showing the approximate location of Test Area 4 (outlined) (cropped plan courtesy of T&V).

23. The bond beam along the bottom of the opening appeared to contain reinforcement and be grouted. Note that the eddy current sensor could not identify differences between continuous bond beam reinforcement and typical vertical wall reinforcement bent and embedded into the bond beam.
24. Where the bond beam is continuous to the corner of the CMU wall, investigation of reinforcement and grout was obstructed by the PEMB structural steel. Reinforcement at the corner could not be verified.

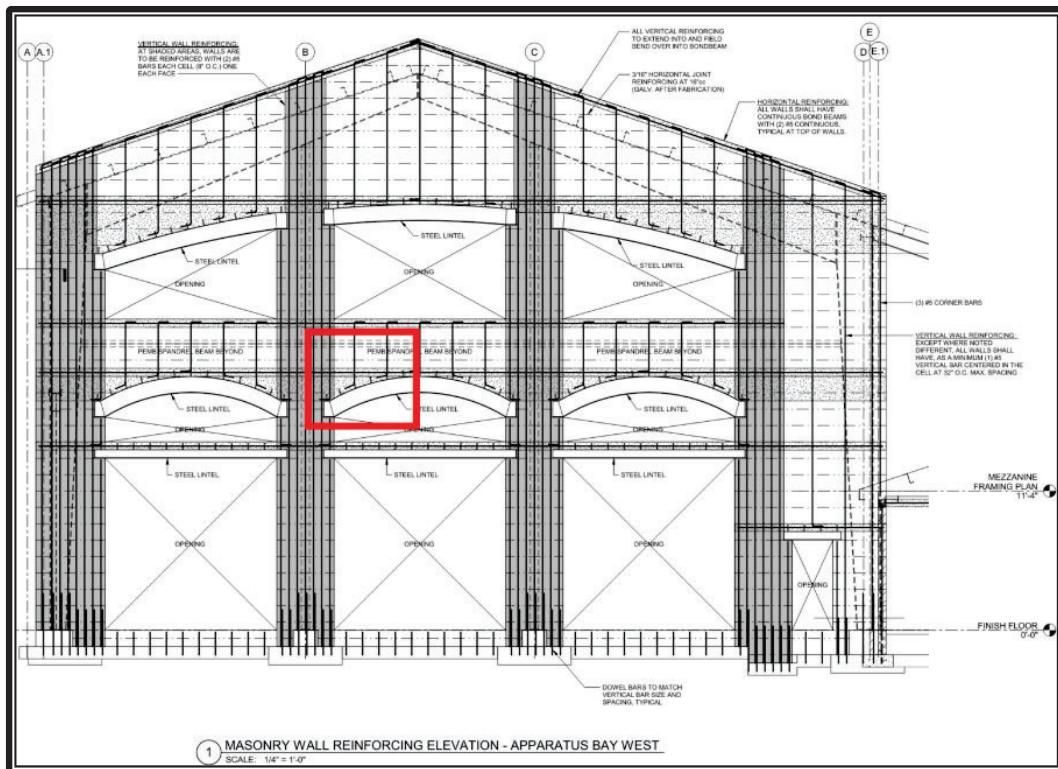
Test Area 5 was located at the west apparatus bay wall and was tested from the east face of the wall (**Figure 8**). The plans (Sheet 3.56) indicate that Test Area 5 should have included a bond beam at the top of the opening, jamb and bearing reinforcement at the opening, and typical wall reinforcement.

**Figure 8:** CMU wall elevation showing the approximate location of Test Area 5 (outlined) (cropped plan courtesy of T&V).

27. The bond beam along the top of the opening appeared to contain reinforcement and be grouted. Note that ABS' investigation could not identify differences between continuous bond beam reinforcement and typical vertical wall reinforcement bent and embedded into the bond beam. Additionally, studs from the steel lintel may have interfered with the observed reinforcement within the bond beam.
28. The cells along the opening's jamb and bearing locations appeared to contain reinforcement and be grouted.
29. Grout and reinforcement observed in the field of the wall were consistent with expected typical wall reinforcement.

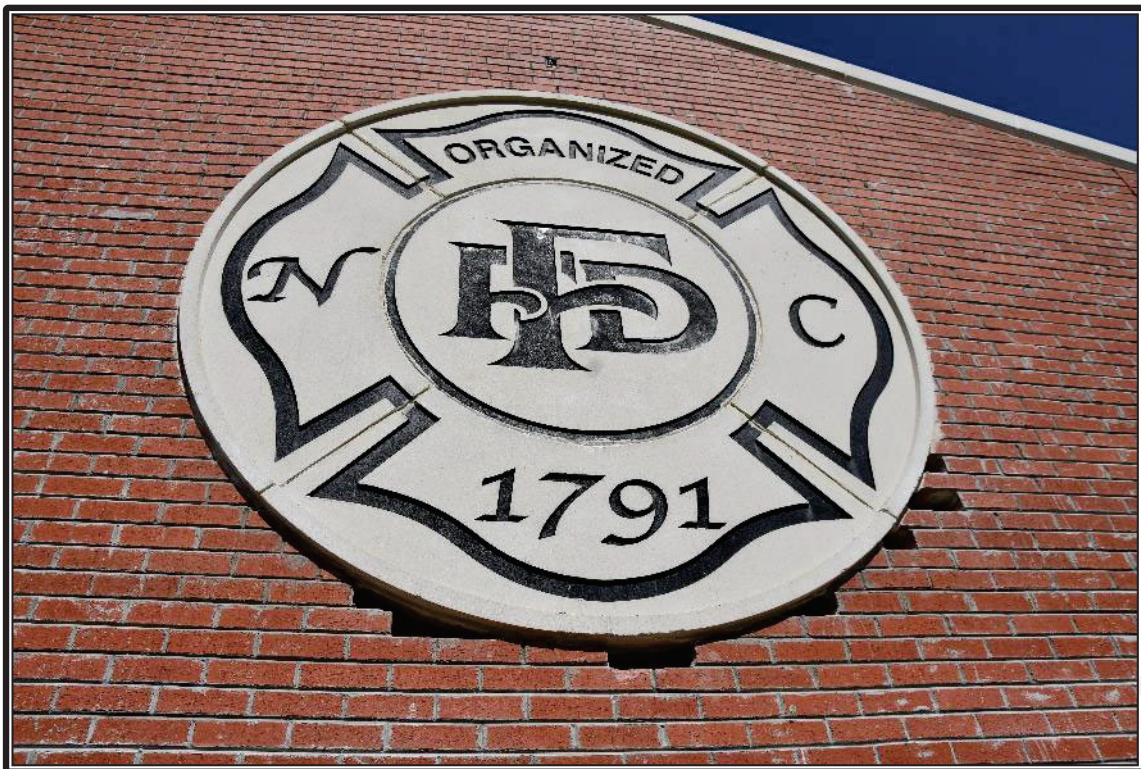
33. The cast stone medallion at Test Area 1 was comprised of five (5) individual sections of cast stone: one (1) circular section at the center surrounded by four (4) sections of a ring (**Photo 6**).

**Photo 6:** View of the cast stone medallion at Test Area 1.

**ABS Recommendation:** ABS recommends that the exterior cast stone as-built conditions identified during ABS' site visit be reviewed by the cast stone manufacturer and EOR. It is ABS' opinion that if the as-built condition of the cast stone is approved by the cast stone manufacturer and EOR, no further action is required; however, if modifications to the attachment method specified by the cast stone manufacturer and EOR are required, removal of the cast stone and/or brick veneer may be necessary.

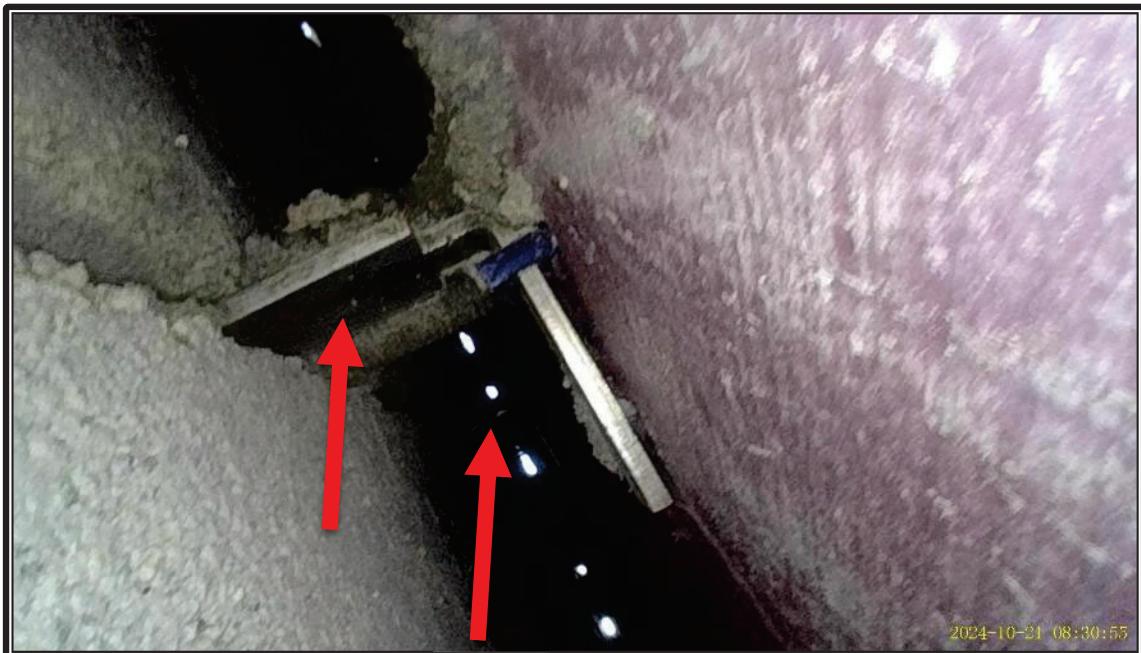
35. At the joint between the lower ring section and the right ring sections, at least two (2) anchors were observed (**Photo 7**). The depth of the anchor flange into the cast stone could not be determined.

If the anchoring of the sector sections depicted on the shop drawings was used for installation of the ring sections at Test Area 1, missing anchors were identified. Due to the limited access and visibility, all anchors could not be identified; however, ABS was able to confirm that no anchors were installed along the bottom and outer edge of the lower ring section. The equivalent sector section from the shop drawings requires three anchors along this edge. It is ABS' opinion that the anchoring of at least one (1) section of the large cast stone medallions is not in compliance with the exterior cast stone shop drawings.

**Photo 7:** Representative view of the anchors at Test Area 1 (arrows).

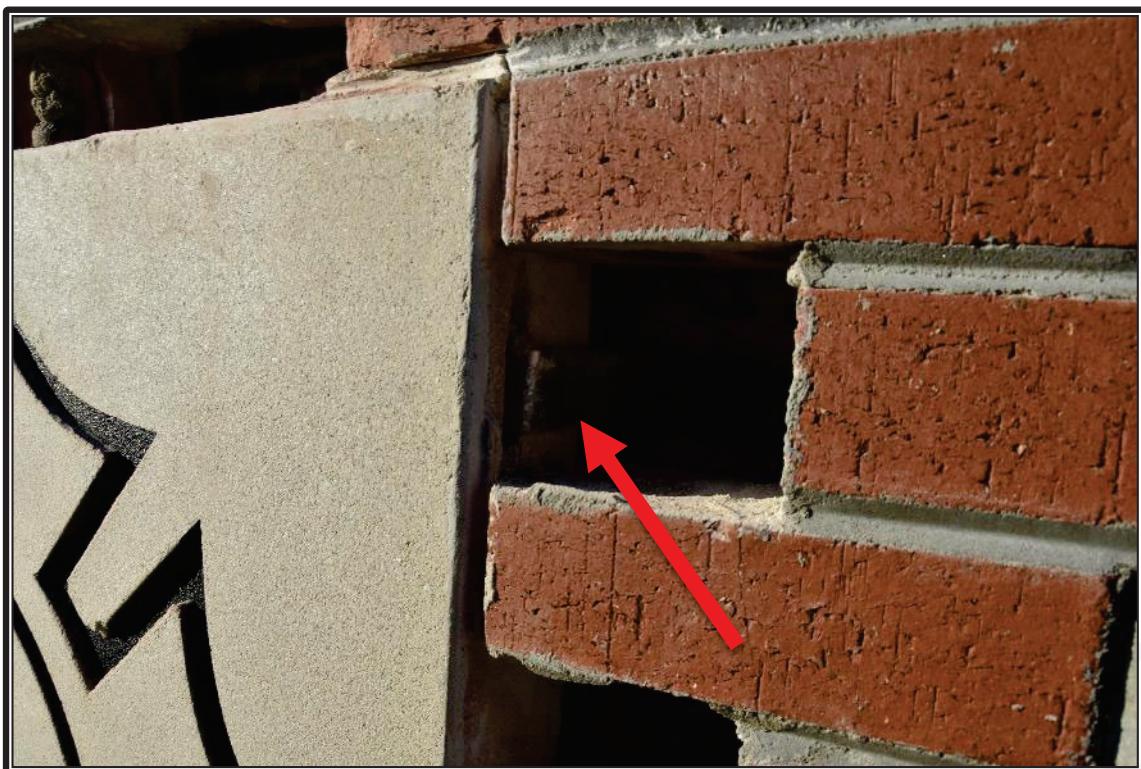
41. The right edge of the cast stone was observed in its entirety by means of removal of two (2) partial brick veneer units and use of the articulating borescope. Along this edge, two (2) anchors holding the cast stone were observed (**Photo 8**). The depth of the anchor flange into the cast stone measured approximately 1.5 inches from the front face. Anchoring along the left edge of the medallion could not be verified without additional brick removal.

**Photo 8:** Representative view of the anchor at Test Area 2 (arrow).

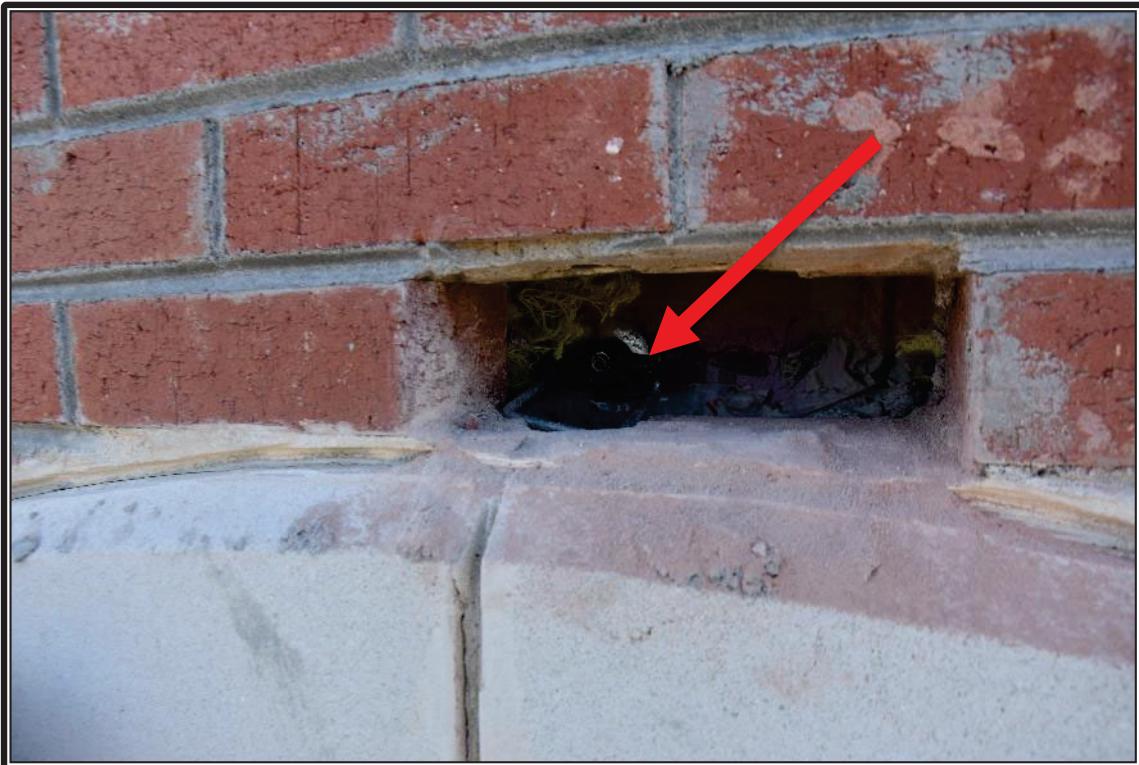
42. The cast stone accents at the jamb of the window were comprised of multiple sections of cast stone.
43. At the joint between sections of cast stone along the jamb of the window opening, an anchor was observed. The depth of the anchor flange into the cast stone could not be determined.
44. At the joint between the cast stone at the top of the jamb and the head of the window opening, no anchor was observed.
45. At the top edge of the cast stone along the head of the window, masonry wall ties were observed at each of the intersecting metal studs (**Photo 9**).
46. At the cast stone water table, masonry wall ties were observed along the top and bottom of the stone at each of the intersecting metal studs.

The cast stone accents at the jamb were installed with anchors between adjacent sections; however, no anchor was observed at the section of cast stone at the top of the jamb. It is ABS' opinion that the anchoring of the cast stone at this location is not in compliance with the exterior cast stone shop drawings.

**Photo 9:** Representative view of a masonry wall tie at the head of the window opening at Test Area 3 (arrow).

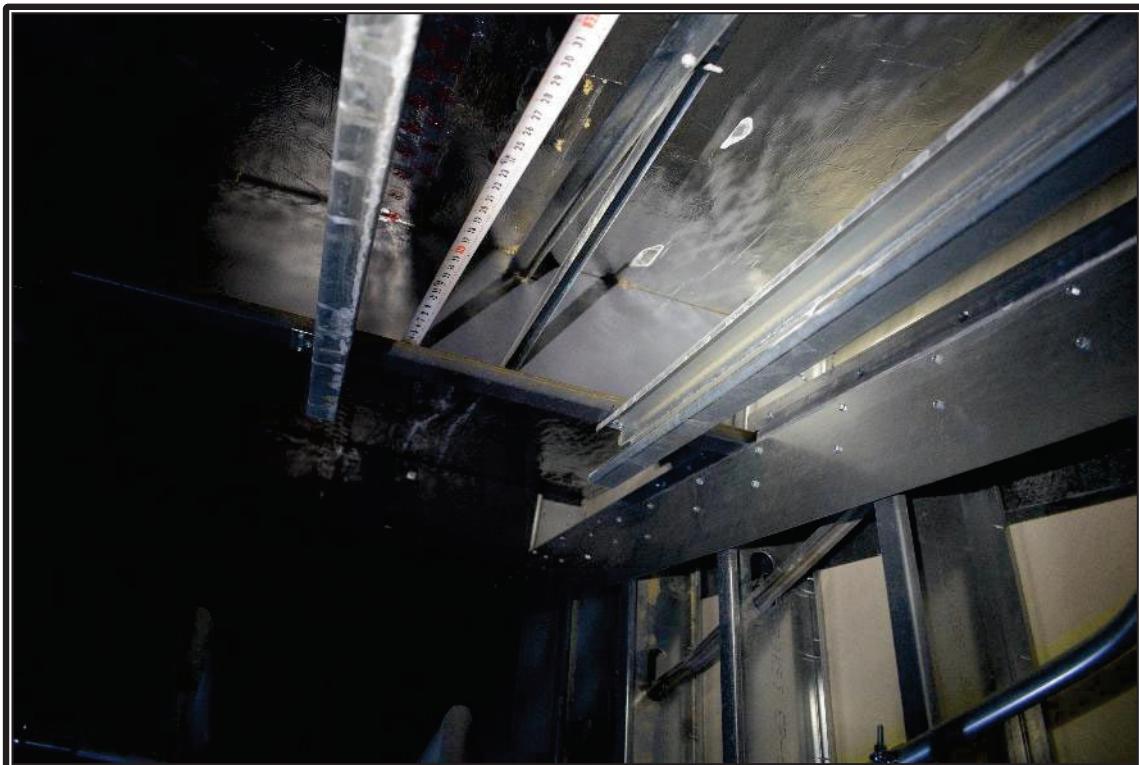
47. Flat metal straps were installed over pre-manufactured slip tracks (**Photo 10**). This condition appears to be an attempt to create a deeper slip track.
48. At many locations, the light-gauge metal studs had little to no clearance to the slip track, creating a condition that will allow little to no movement (**Photo 11**).
49. Bridging was missing within 12 inches of the slip track on multiple light-gauge metal walls (**Photo 12**).

**Photo 10:** Representative view of the metal strapping at the slip track.

It is ABS' opinion that all non-complying components that may also be compromised due to long-term exposure to the elements should be repaired or replaced to be in compliance with the approved architectural and structural plans.

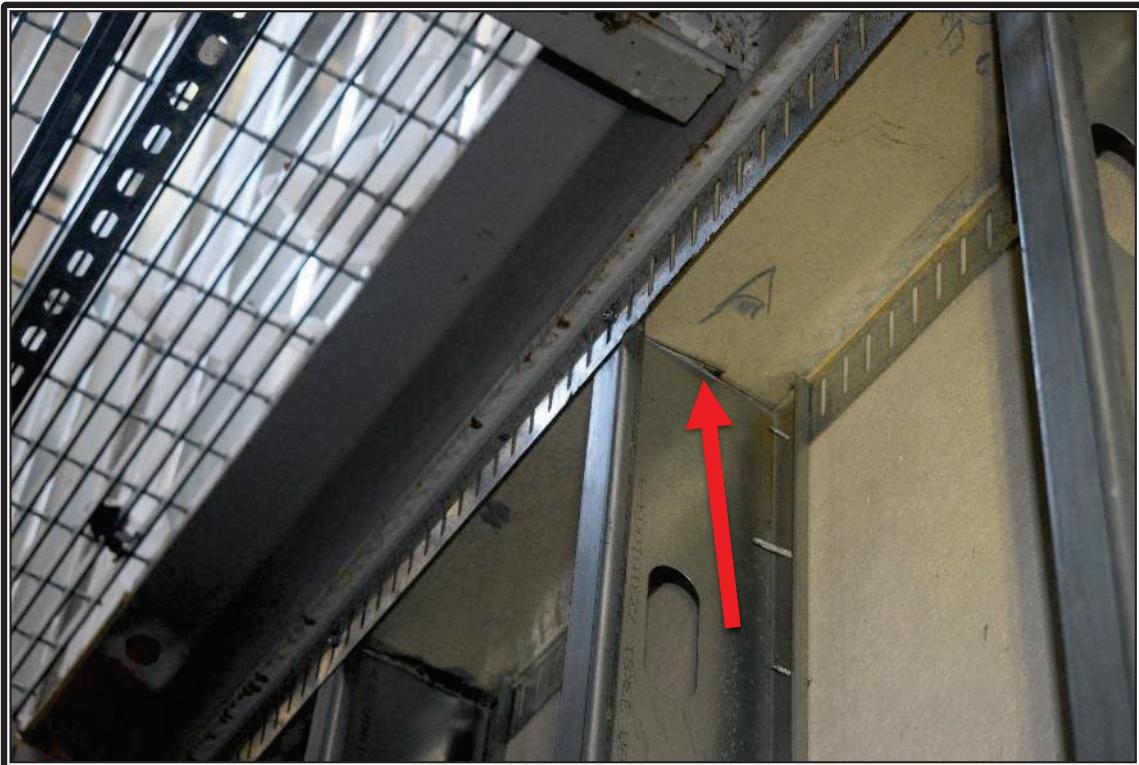
**Photo 11:** Representative view of a light-gauge metal stud with inadequate clearance at the slip track (arrow).

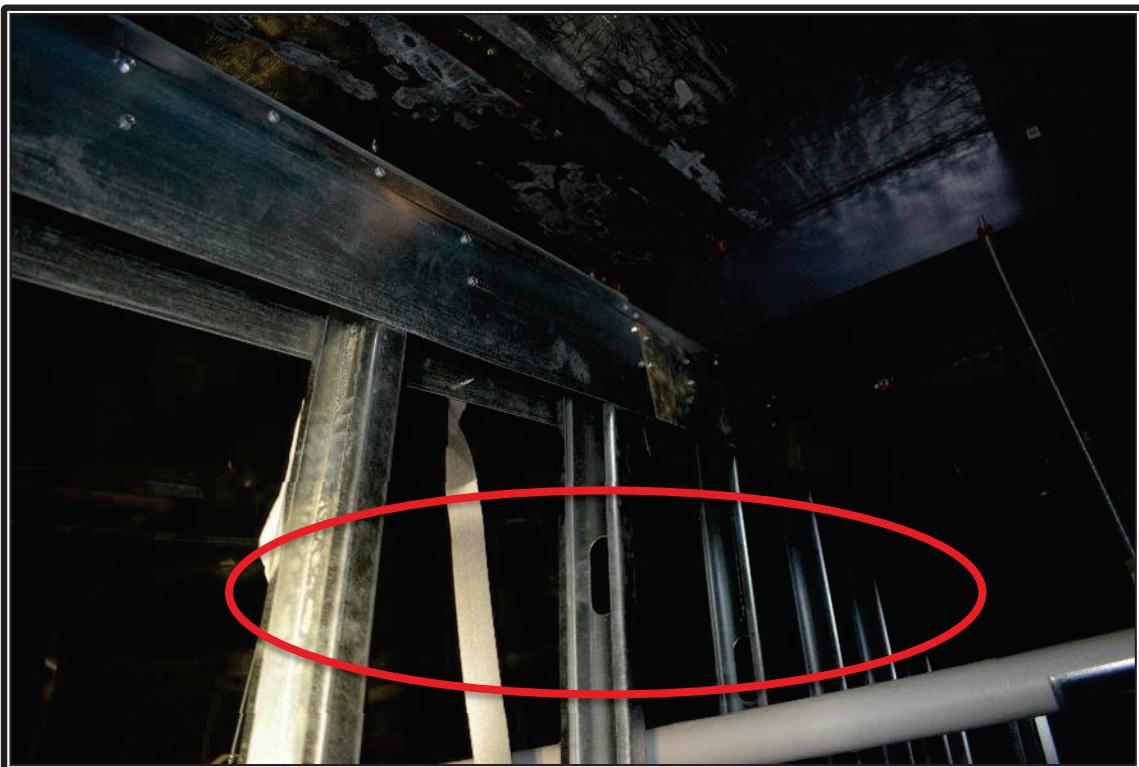
**Photo 12:** Representative view of the missing light-gauge metal wall bridging (oval).

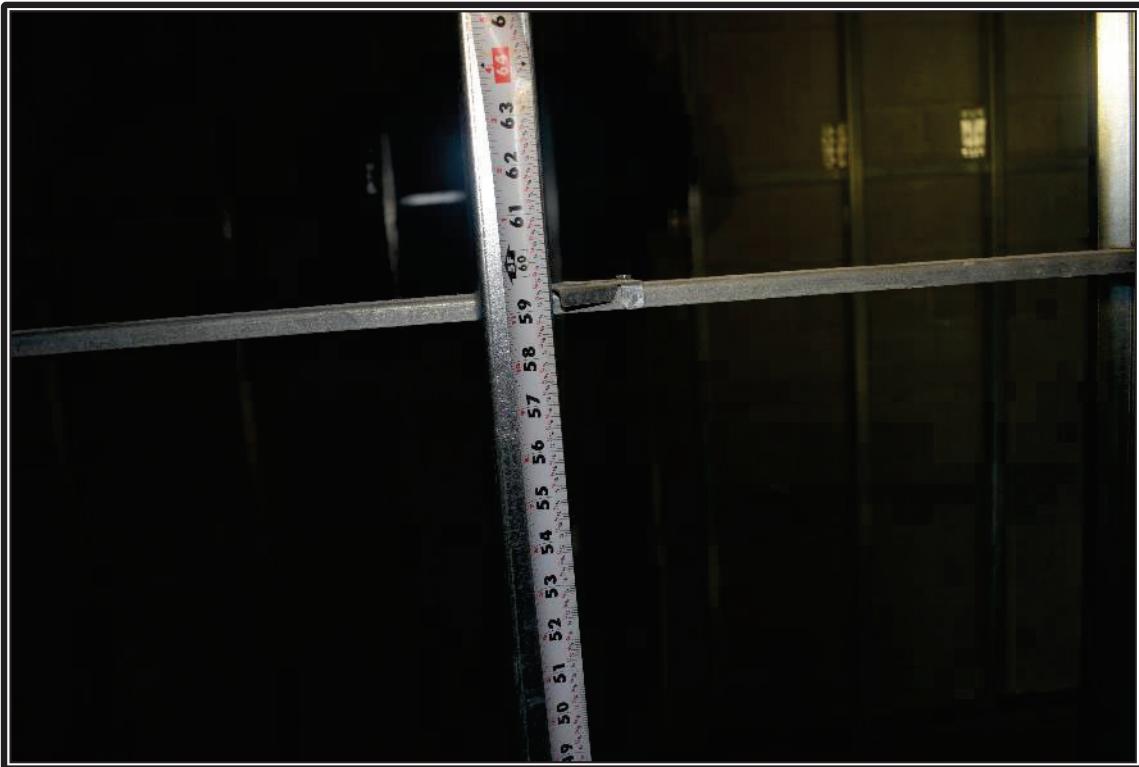
50. The first row of light-gauge metal wall bridging was measured at 59 inches above the concrete slab and 72 inches on center above that (**Photo 13**). Detail 3 on Sheet 3.04 indicates a 48-inch maximum distance to the first row of bridging above the concrete slab.
51. At the arch above window openings, the upper metal track was shimmed with gypsum wallboard (GWB) at multiple locations (**Photo 14**). No box header was observed over these openings as required on Sheet 3.04 (**Photo 15**).

**Photo 13:** Representative view of the measured distance to the first row of bridging above the concrete slab.

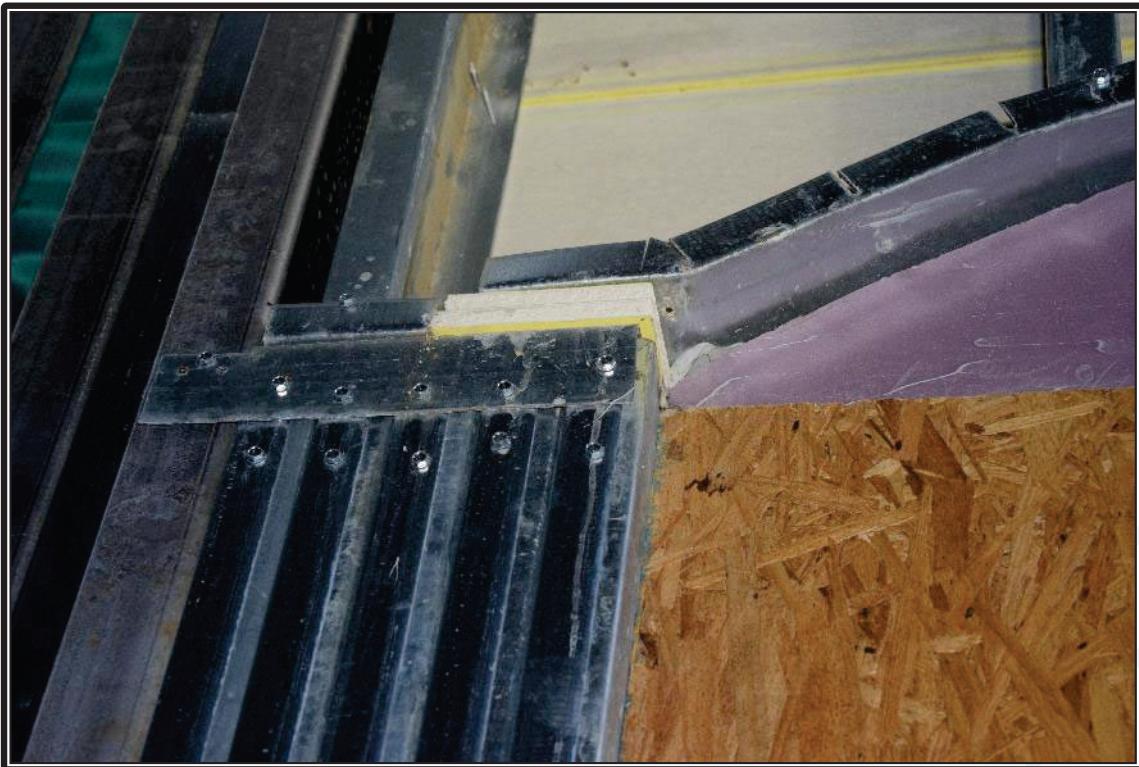
**Photo 14:** Representative view of GWB used as shims between the arched track and jack studs (arrow).

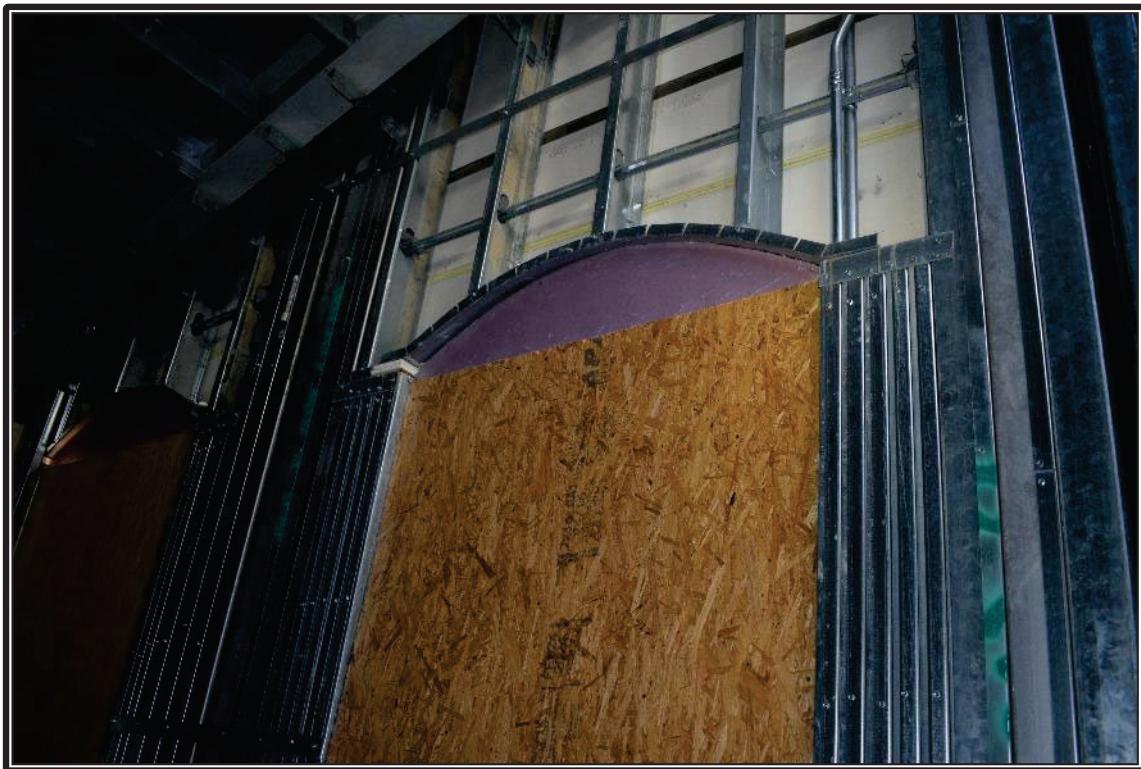
**Photo 15:** Representative view of an arched opening with no header.

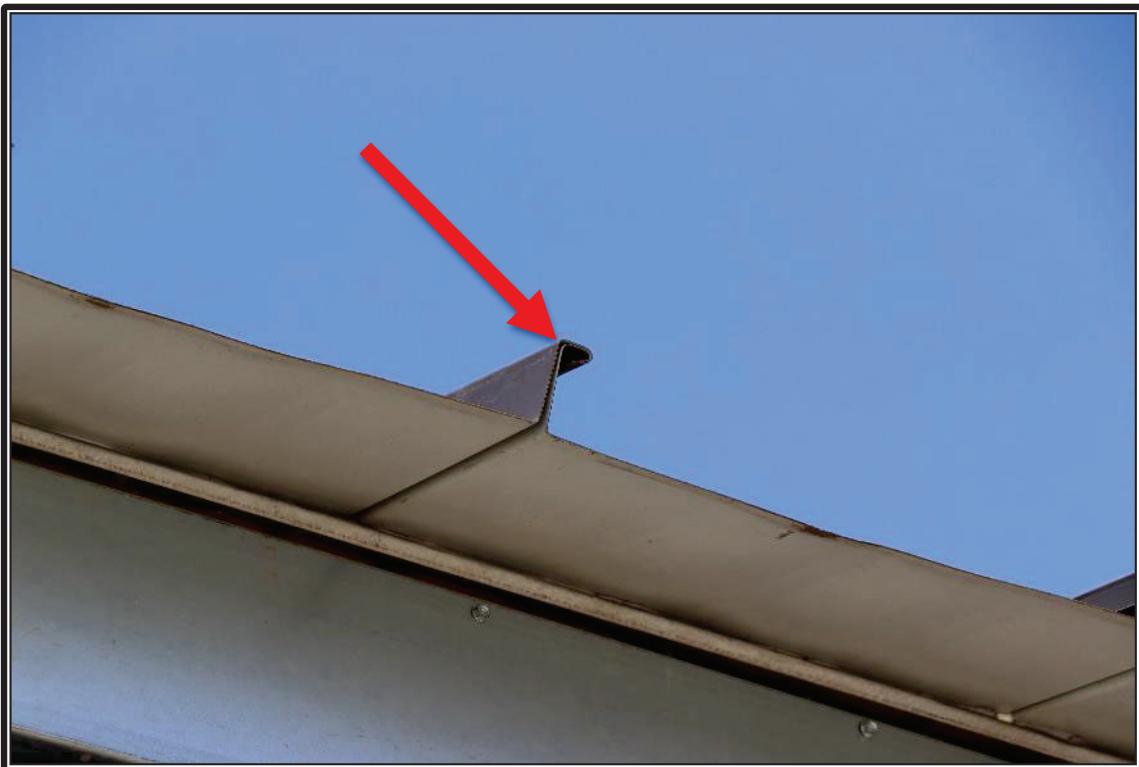
**Photo 16:** Representative view of a 90-degree single roll (1 phase) standing seam metal roof panel (arrow).

**ABS Recommendation:** Because of the extent of improper installation of the roof assembly identified during ABS' site visit and incomplete roof construction resulting in multiple points of entry for water intrusion, in addition to components now compromised due to long-term exposure to the elements, it is ABS' opinion that the entire roof assembly should be removed and replaced.

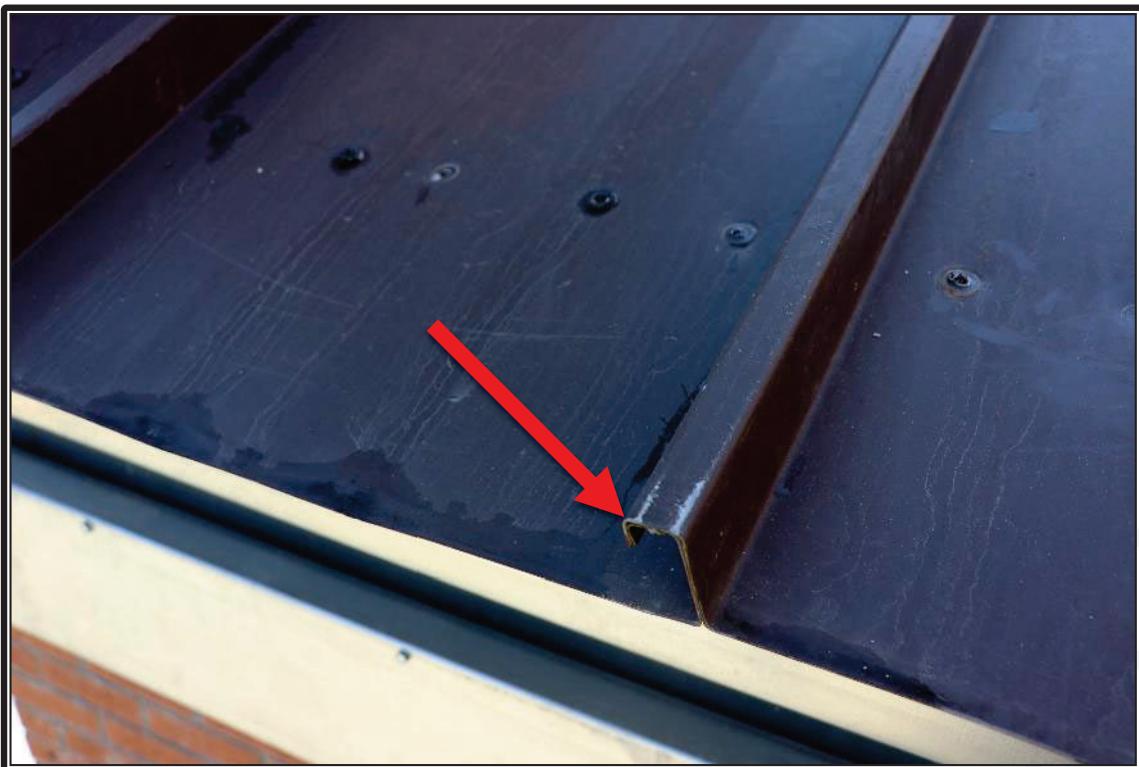
**Photo 17:** Representative view of an unseamed standing seam metal roof panel (arrow).

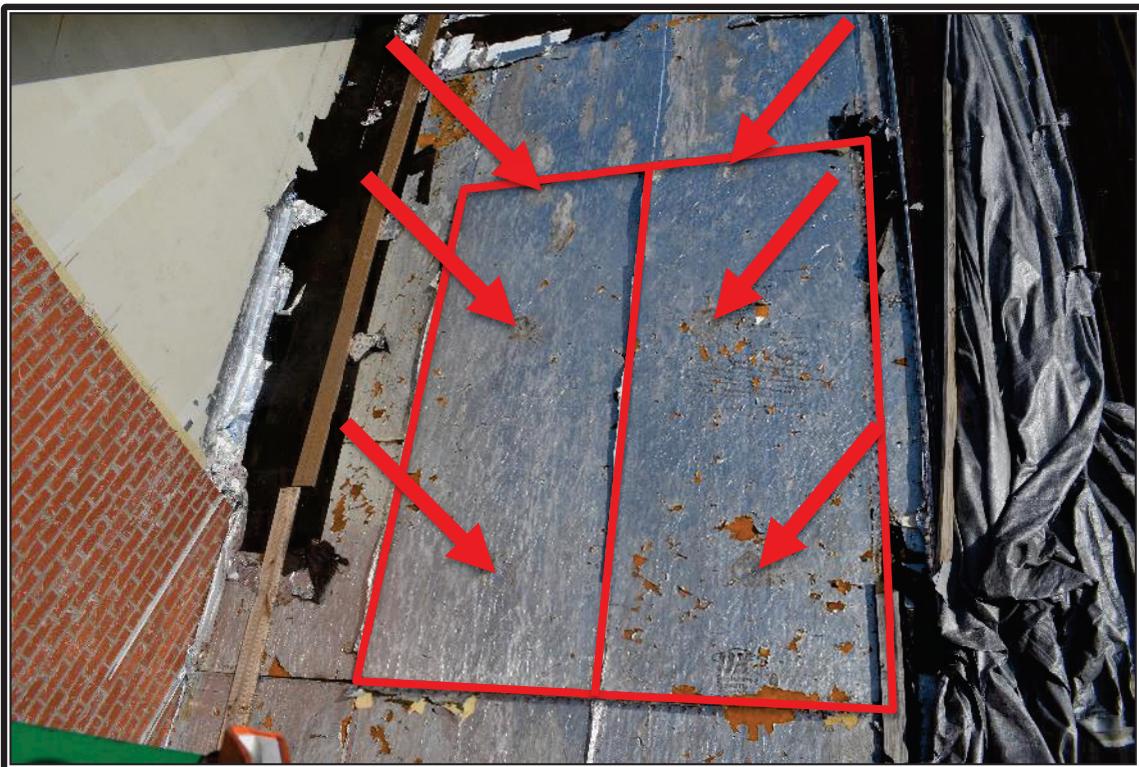
57. The rigid insulation boards were fastened to the roof structure with 6-inch self-tapping screws spaced in accordance with the purlin spacing (**Photo 18**). Each insulation board generally exhibited 2 or 3 fasteners. The 6-inch screws fastened both layers of insulation to the roof. Each screw was partially held in place by 5-inch by 5-inch light-gauge metal plates located at the top of the upper layer of insulation. At most observed locations, the metal plate was covered by a second metal plate of the same size, which was fastened to the bottom disc with a small screw. Where the upper insulation boards were temporarily removed by ABS, no fasteners at the bottom layer of insulation were observed.

**Photo 18:** Representative view of fastener locations installed through the upper two (2) rigid insulation boards (temporarily removed by ABS) (arrows).

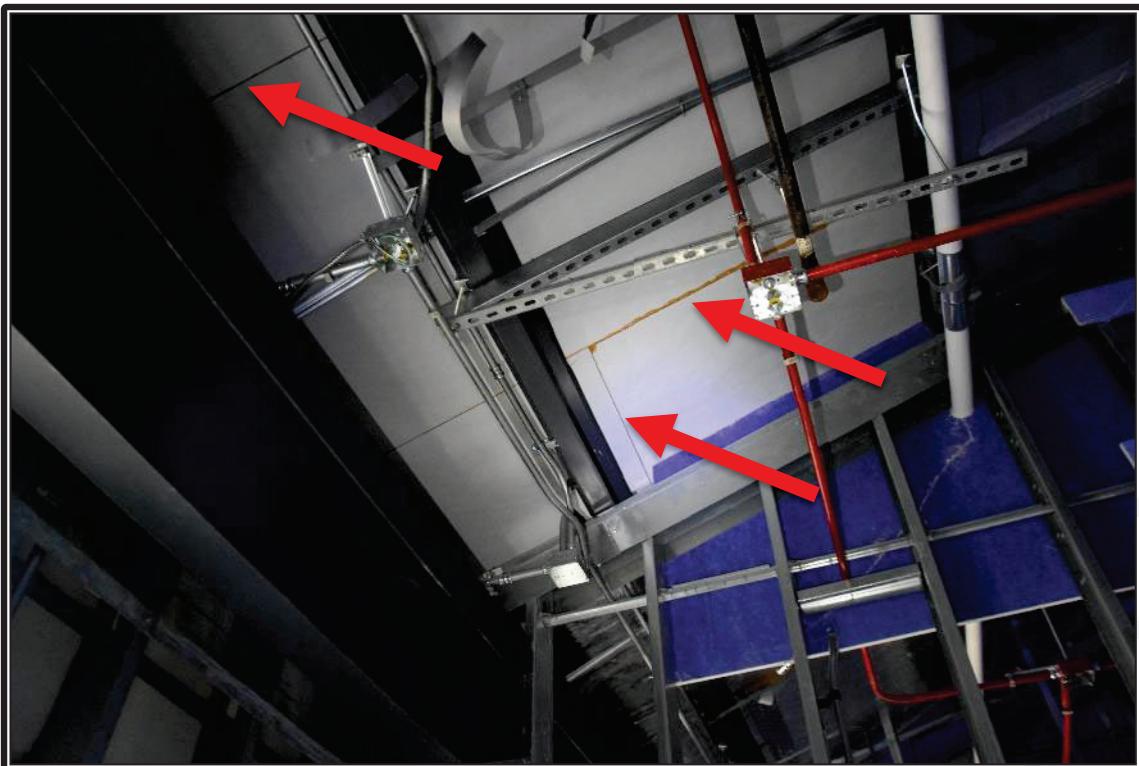
58. The seams between rigid insulation boards were offset between each layer. Seam tape was observed along some, but not all, of the seams. At some locations, closure strips were observed at the board seams. From the interior of the building, it appeared that most of the seams along the bottom surface of the lower insulation boards were installed with a foil tape; however, some untaped seams were observed (**Photo 19**).

**Photo 19:** Representative view of seams with no tape or closure strip (arrows).

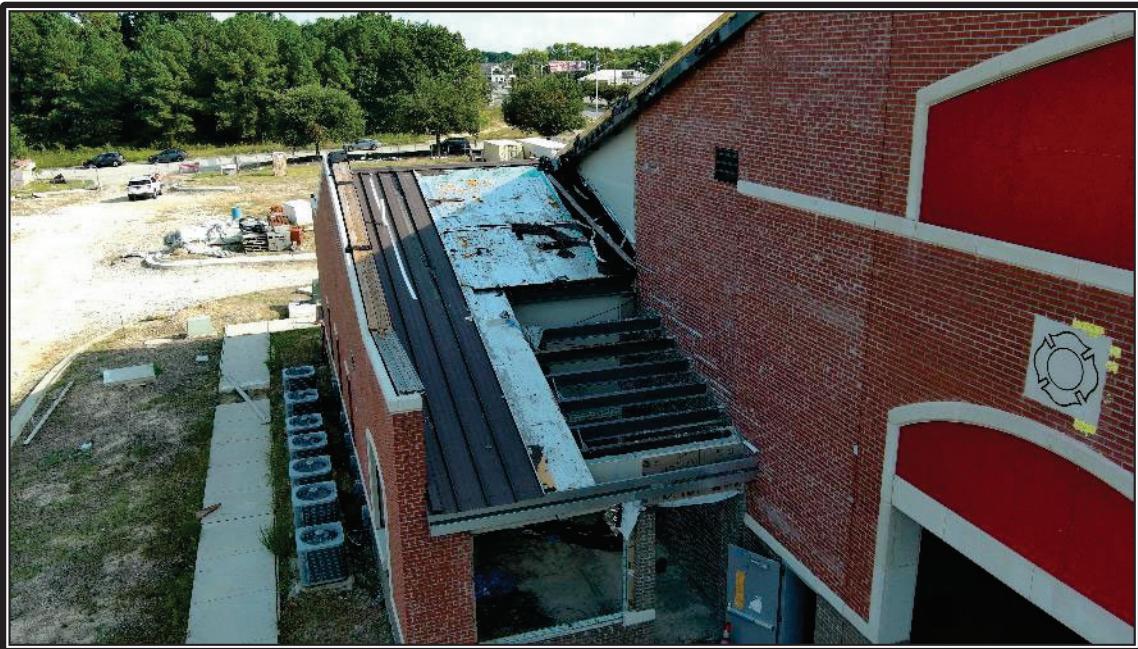
**Photo 20:** Representative view of deteriorated roof assembly materials at a section of incomplete roof.
