## ENGINEERING REPORT

**November 12, 2025**

**RE: Construction Defect Assessment  
City of Fayetteville  
Fayetteville Fire Department New Sub-Station No. 4  
4210 Bragg Boulevard  
Fayetteville, North Carolina 28303  
ABS File Number: 900.25030**

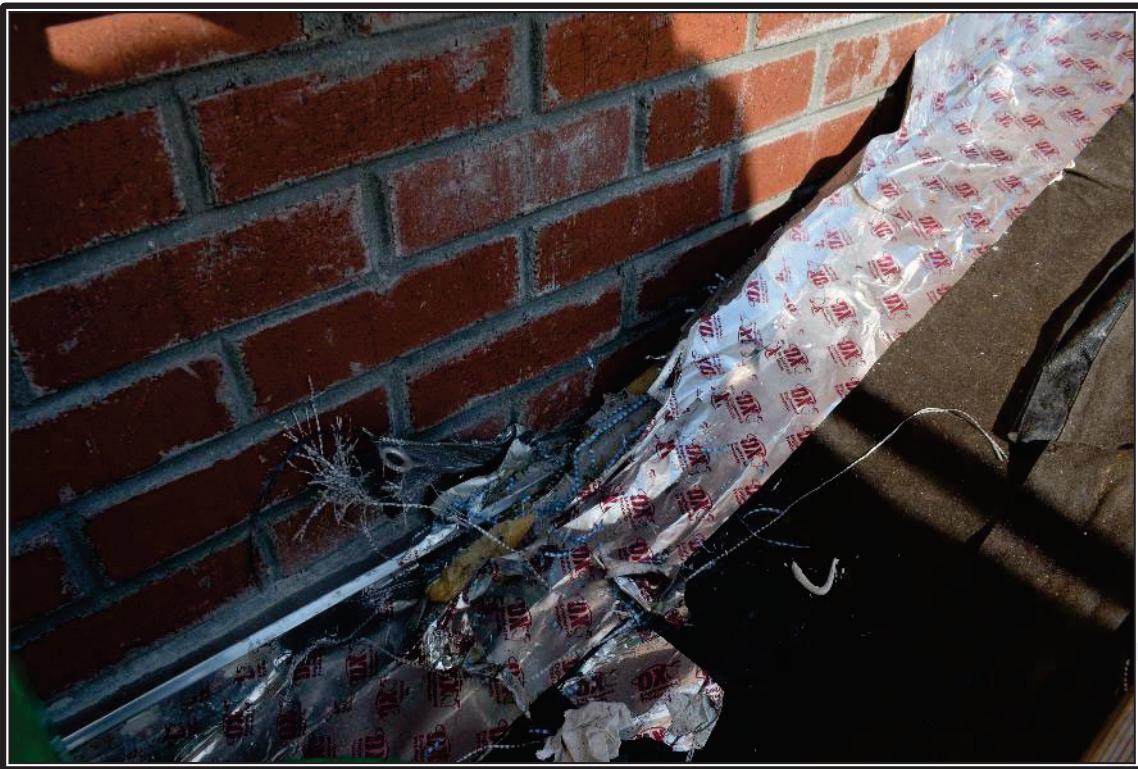
**Photo 21:** Representative view of through-wall flashing penetrating the roof insulation.

**ABS Recommendation:** Because of the extent of improper installation of the roof assembly identified during ABS' site visit and incomplete roof construction resulting in multiple points of entry for water intrusion, in addition to components now compromised due to long-term exposure to the elements, it is ABS' opinion that the entire roof assembly should be removed and replaced.

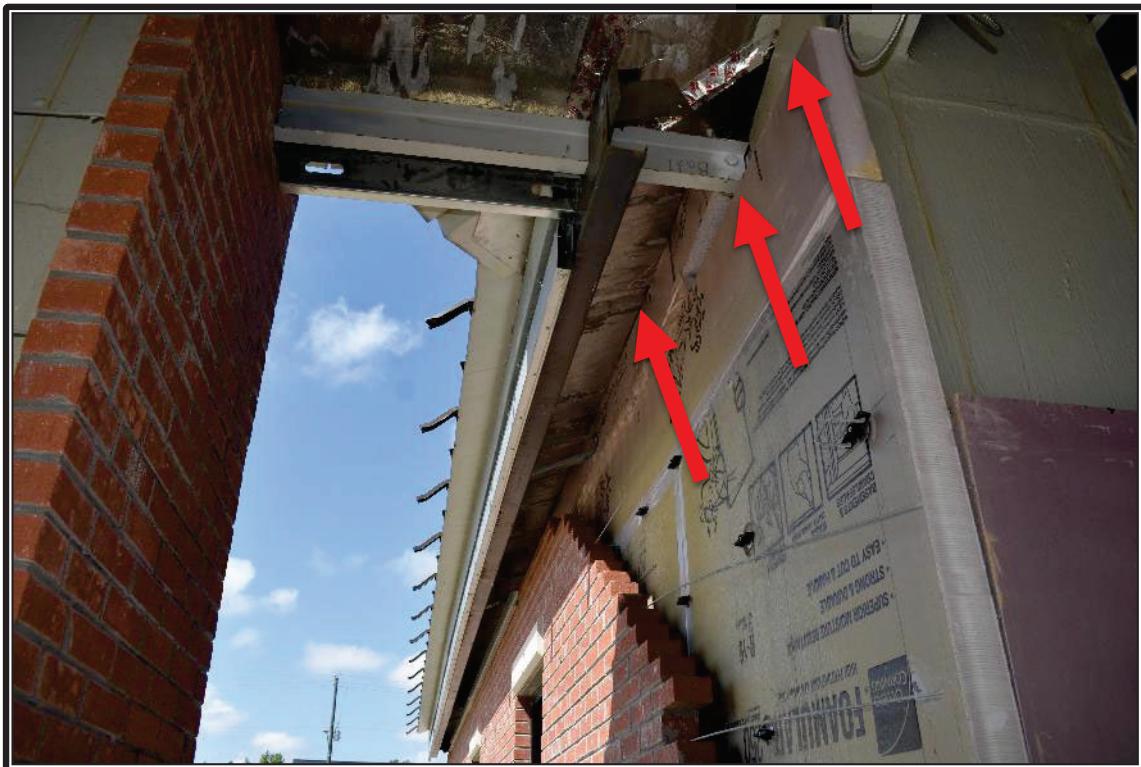
**Photo 22:** Representative view of missing spray foam insulation at the roof-to-exterior-wall interface (arrows).

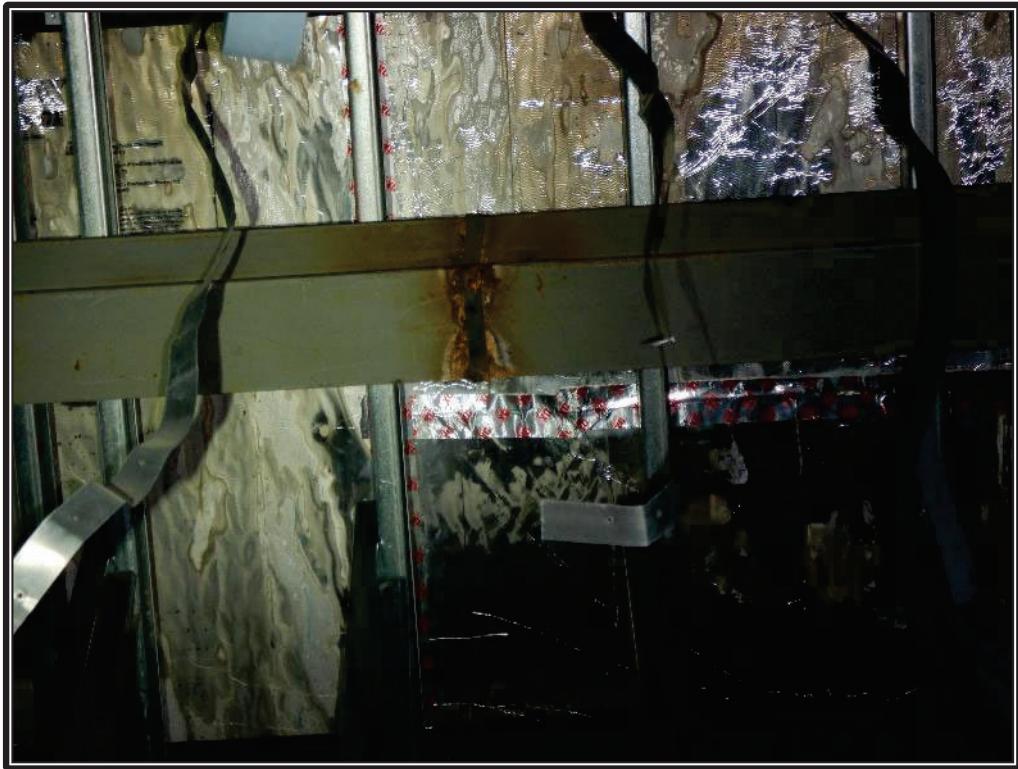
**Photo 24:** Representative view of an apparent uncoated field weld with surface deterioration at a PEMB beam splice.

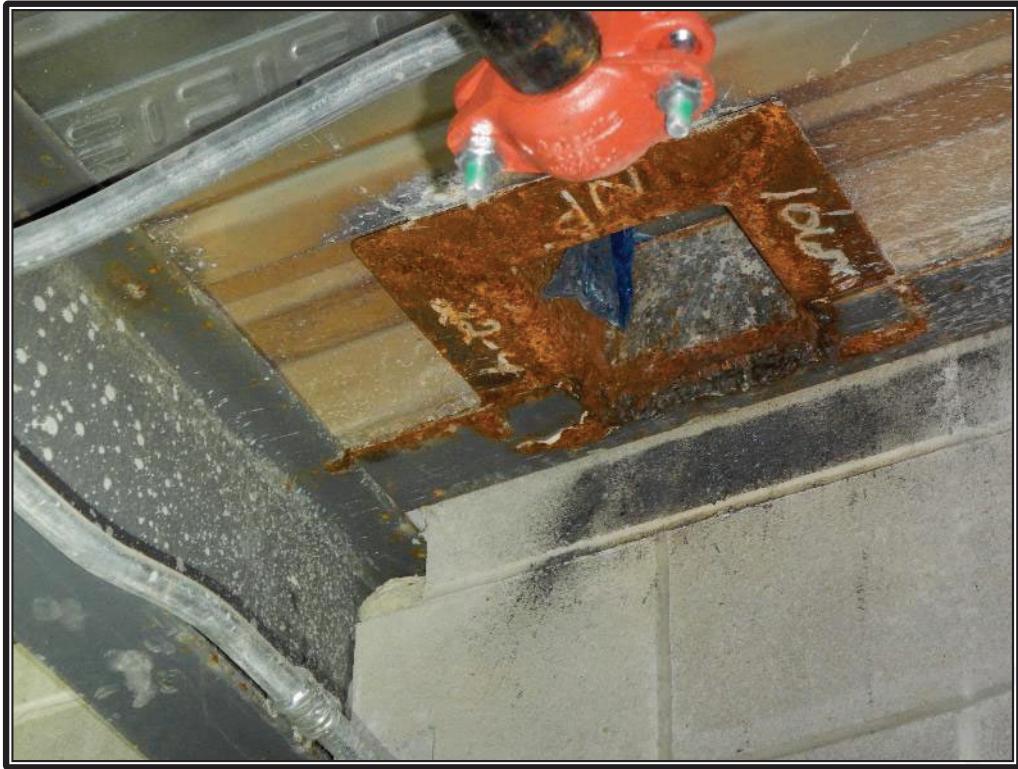
**Photo 25:** Representative view of an apparent uncoated field weld with surface deterioration.

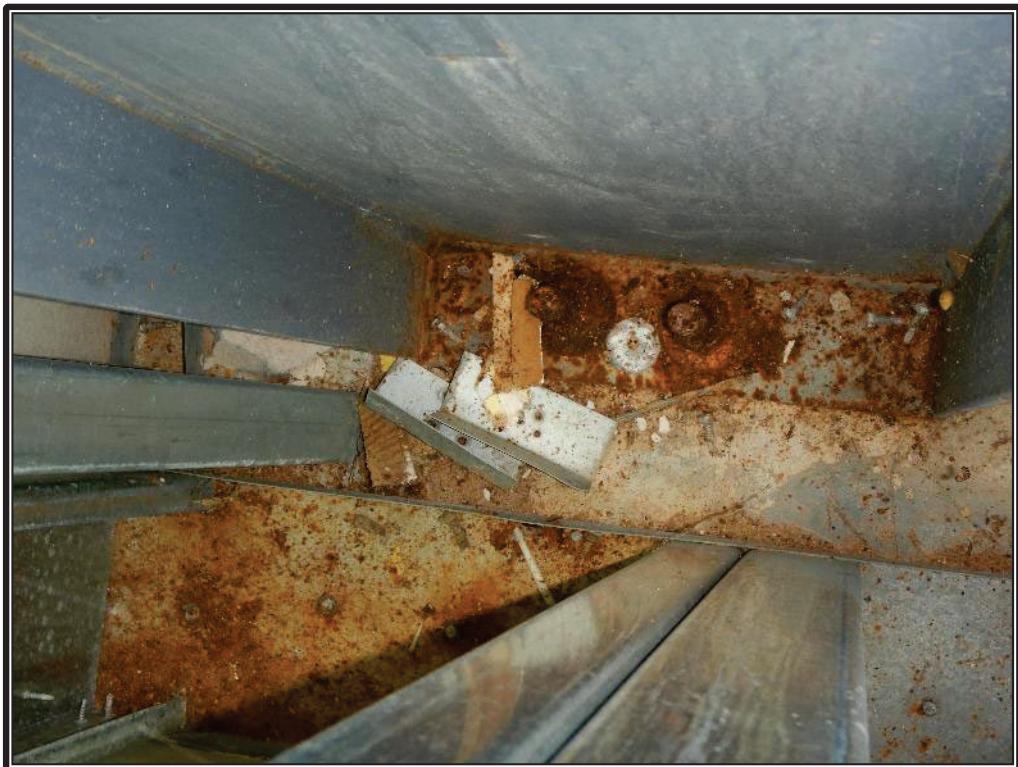
**Photo 26:** Representative view of the bolts and structural steel with surface corrosion.

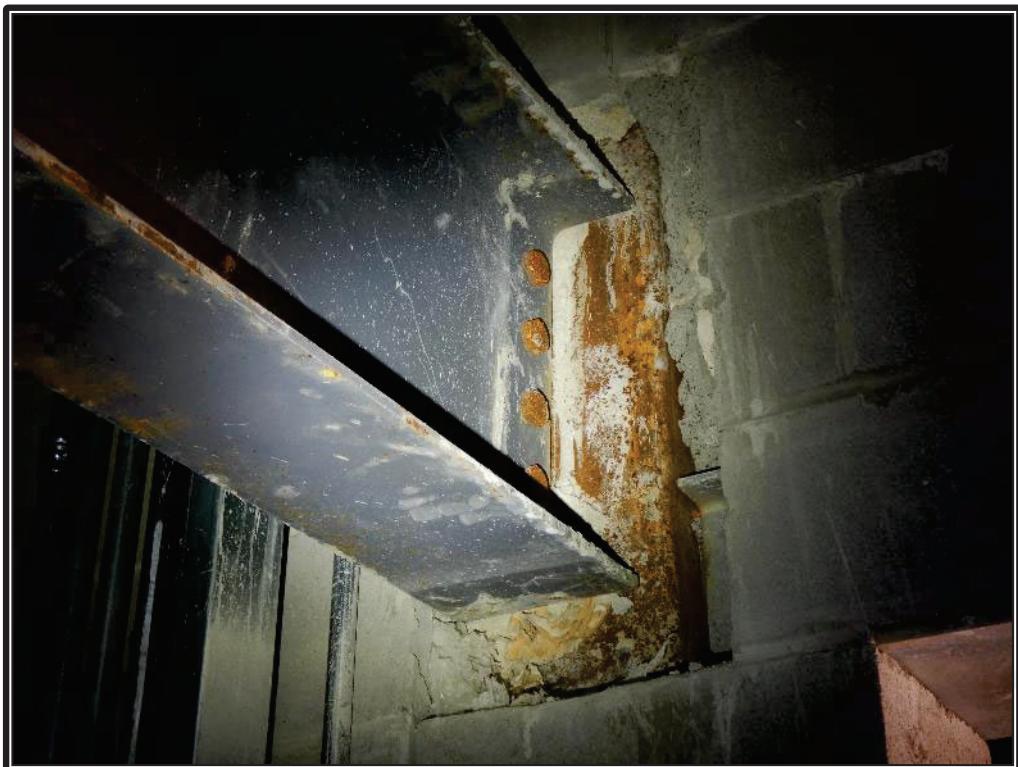
**Photo 27:** Representative view of the bolts and structural steel with surface corrosion.

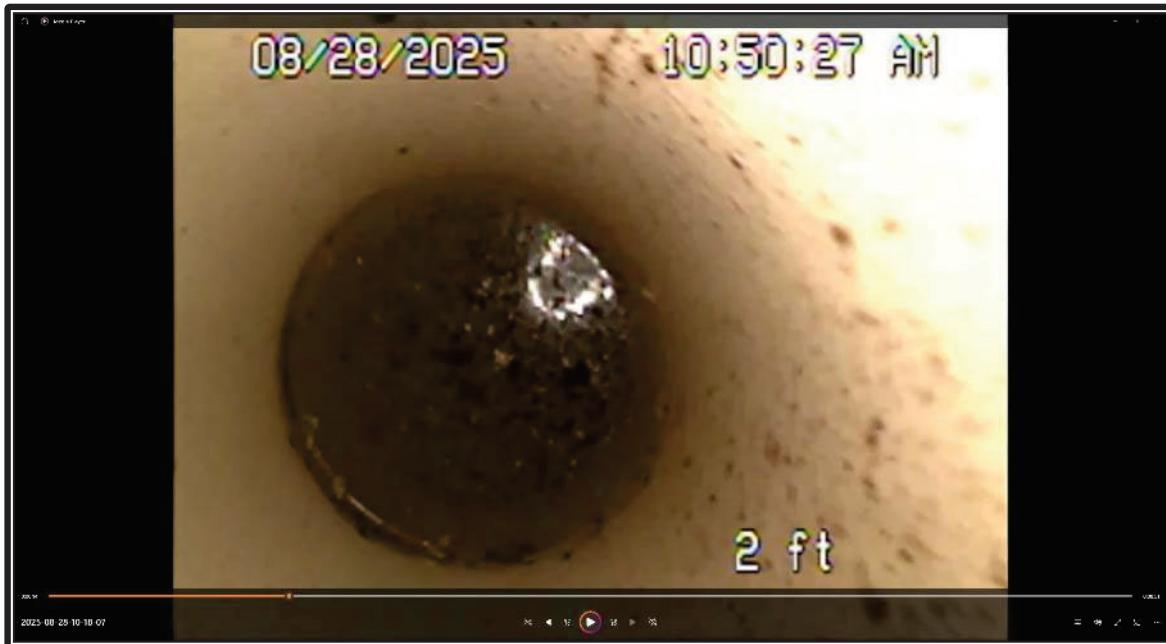
**Photo 28:** Representative view of a water/debris-filled pipe (courtesy of Next Level).

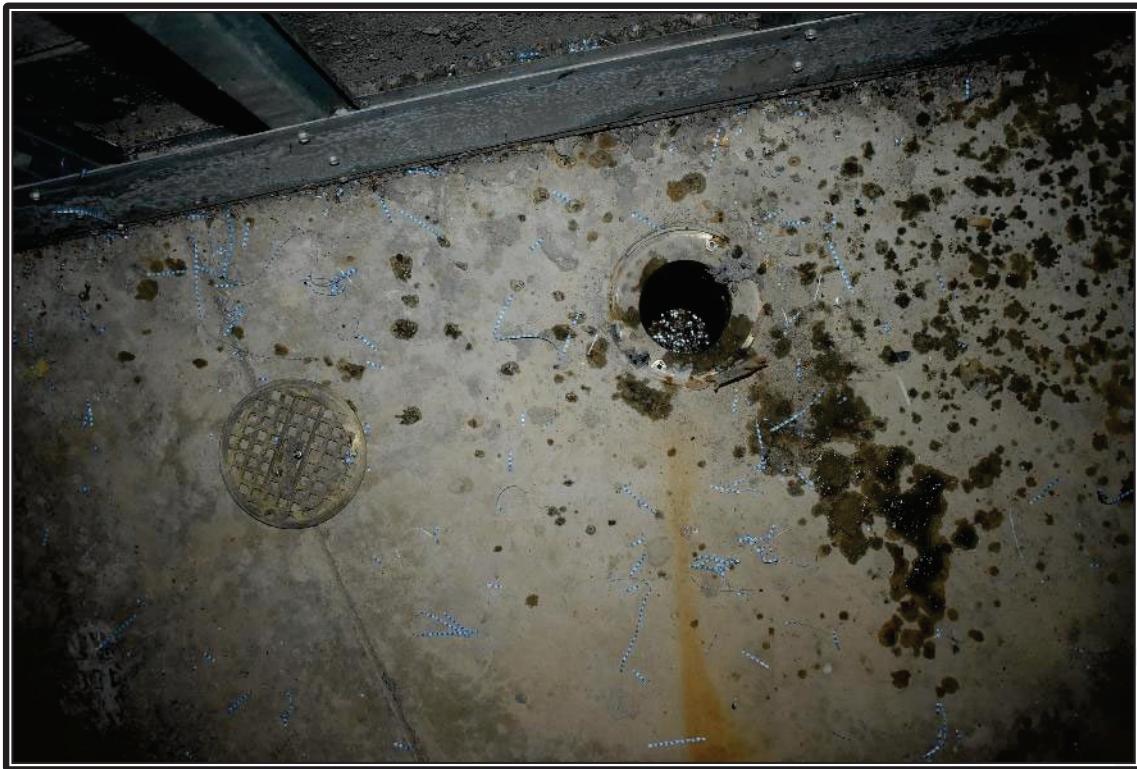
**Photo 29:** Representative view of a pipe filled with watery sludge.

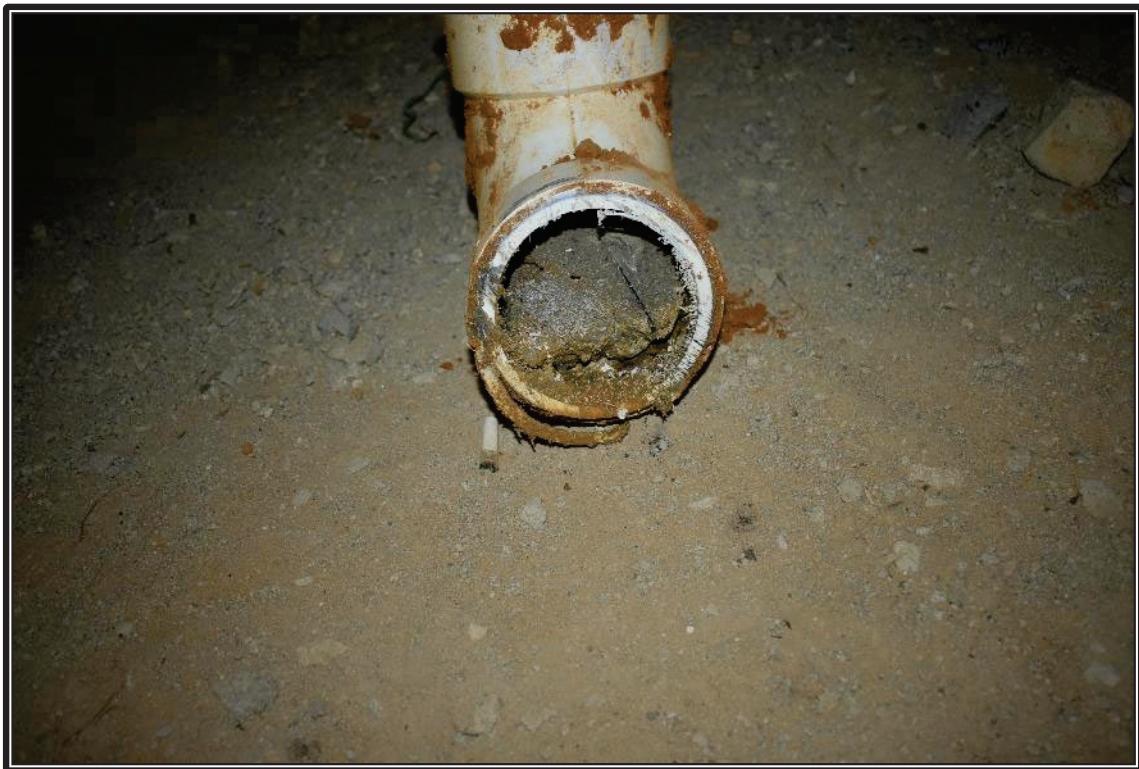
**Photo 30:** View of debris/dirt/stone-filled pipe.

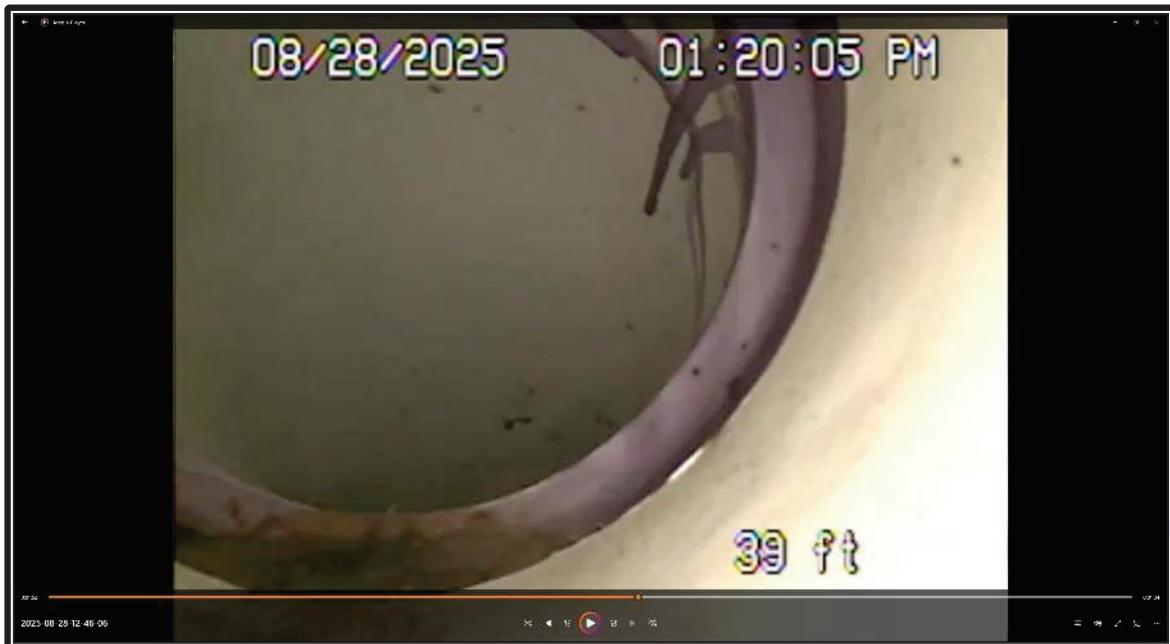
**Photo 31:** Representative view of a partially separated or poorly fit pipe joint (courtesy of Next Level).

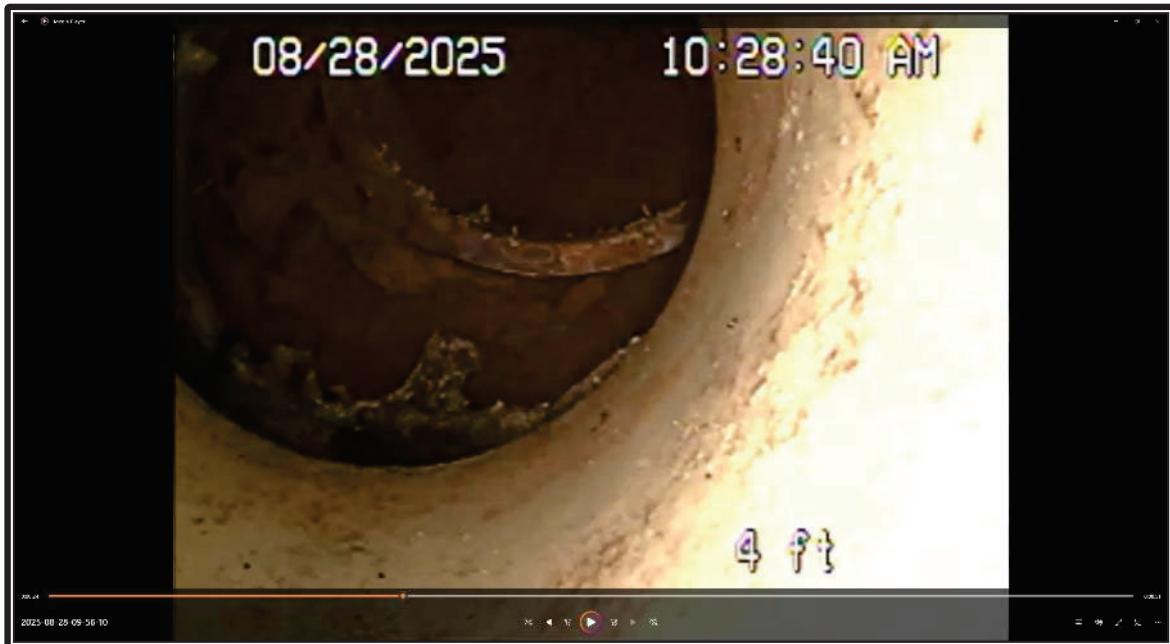
**Photo 32:** Representative view of a separated/cracked/collapsed section of pipe (courtesy of Next Level).

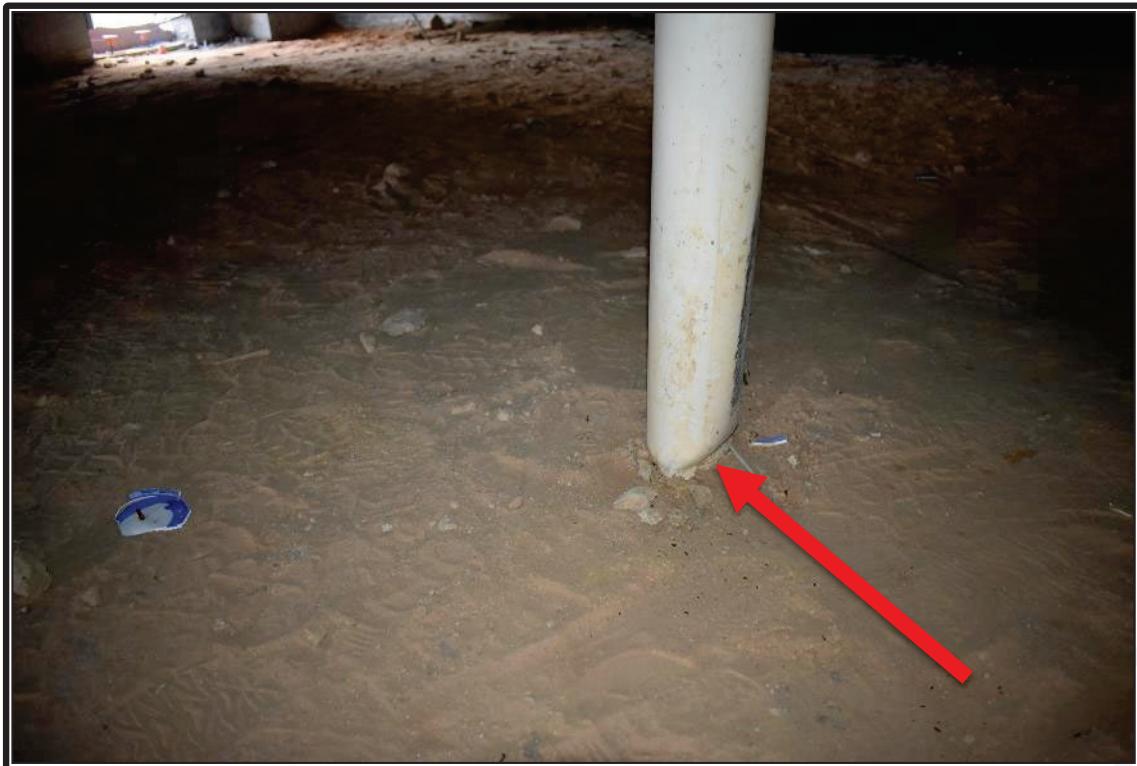
**Photo 33:** Representative view of partially bent over and collapsed pipe stub (arrow).
