**Item Title:** Post Incident Review Program Update

# Wake County Post Incident Review

# Post Incident Review Report

House Fire with Fatality  
1108 Leach Street  
Raleigh, NC 27603  
Incident 11-0015384

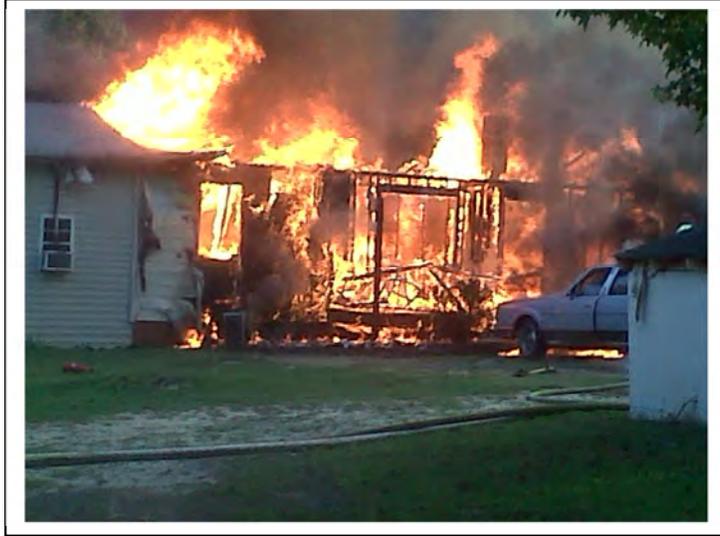
- The above photo was taken by a firefighter shortly after arrival.

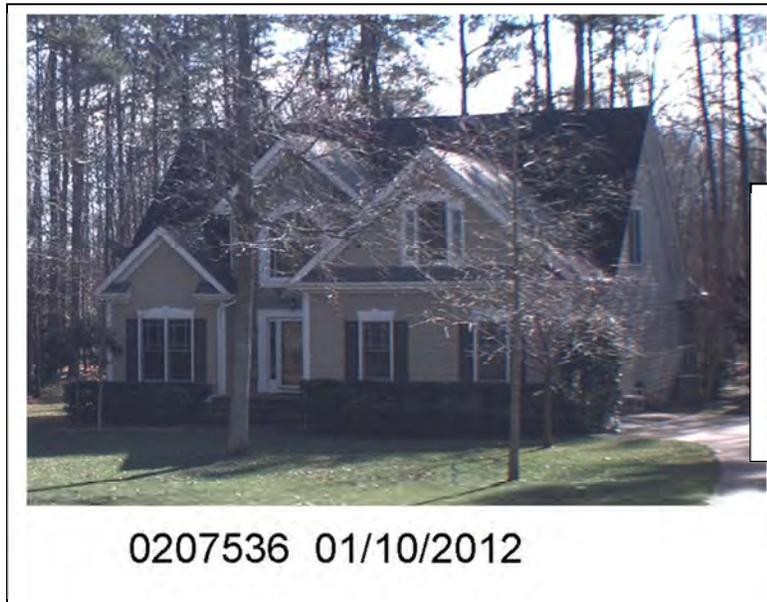
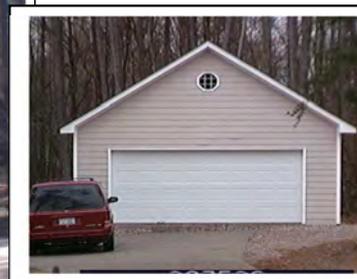
- The above photos are from the tax records.

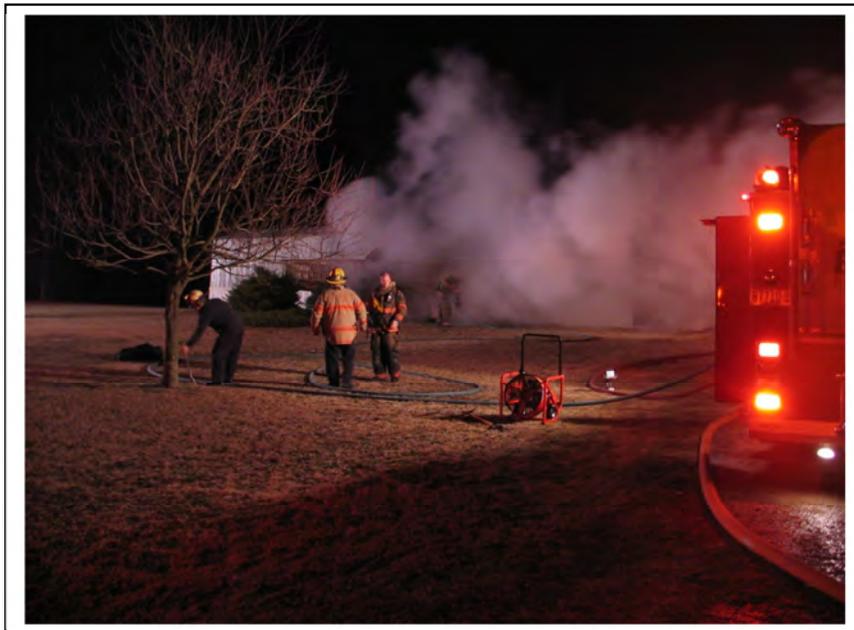
- The above photo was taken by a firefighter shortly after arrival.
