## ENGINEERING REPORT

**November 12, 2025**

**RE: Construction Defect Assessment  
City of Fayetteville  
Fayetteville Fire Department New Sub-Station No. 4  
4210 Bragg Boulevard  
Fayetteville, North Carolina 28303  
ABS File Number: 900.25030**

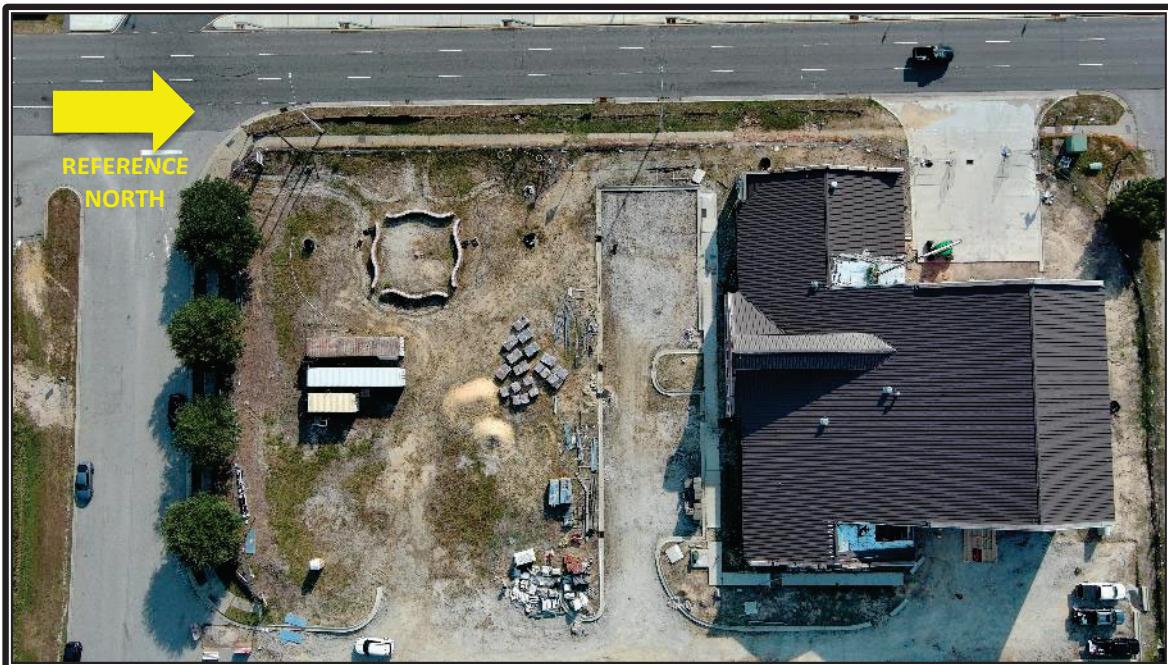
**Photo 1:** Aerial drone view of the site.

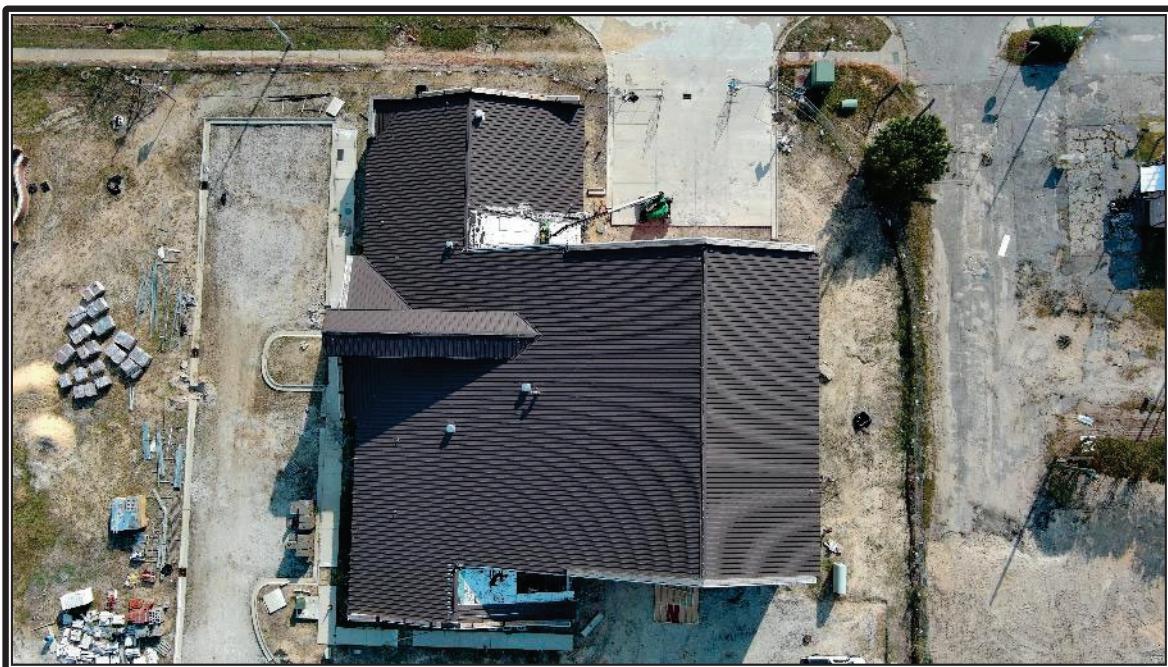
**Photo 2:** Aerial drone view of the building.

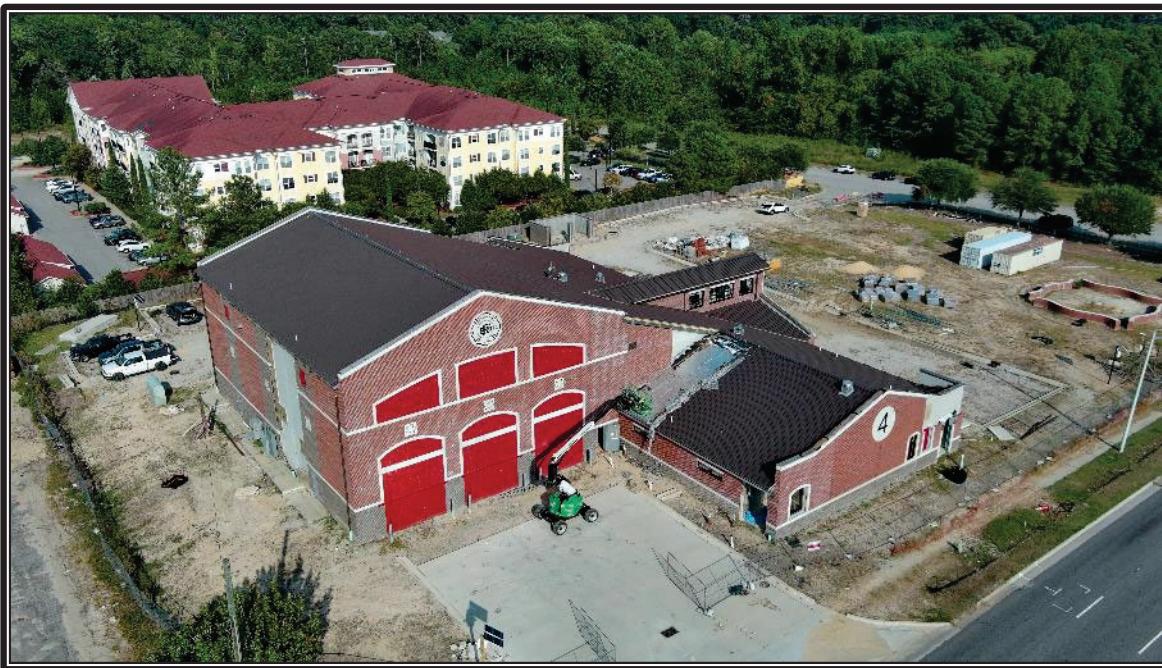
**Photo 3:** Aerial drone view of the west (front) elevation of the building.

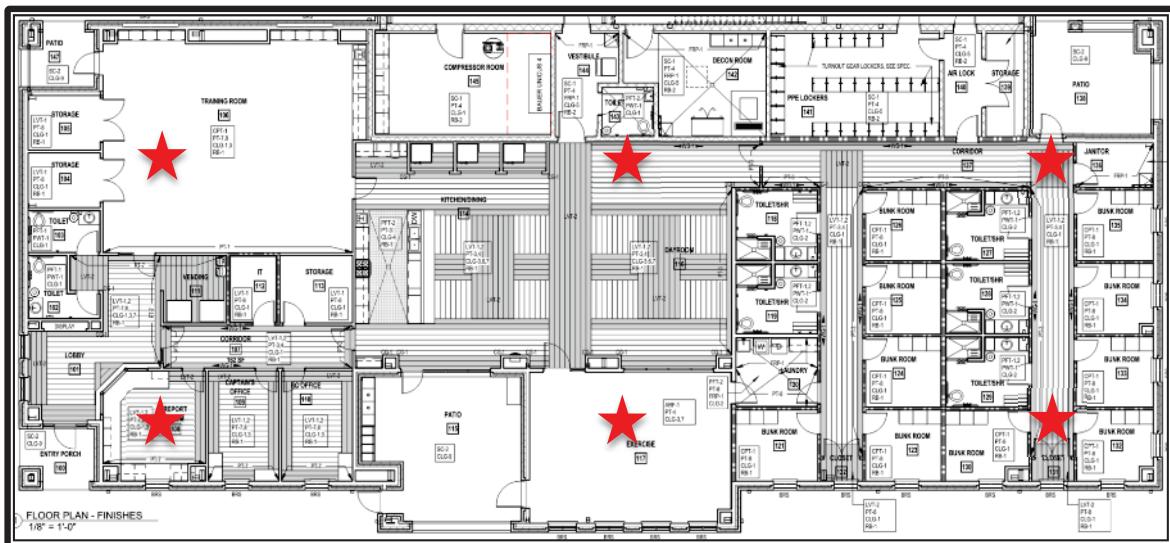
2. At each of the core drilling locations, a 10-mil vapor retarder was observed at the underside of the concrete slab above the stone base.
3. WWF was observed within each of the six (6) cores. Measured from the bottom of the slab core, the cover of the wire at three (3) of the cores measured approximately 1 inch; at the three (3) remaining cores, the cover of the wire measured approximately 1.25 inches, 0.75 inches, and 0.5 inches. The 4-inch diameter concrete cores each intersected one (1) parallel wire, indicating that the spacing of the welded wire fabric exceeded 4 inches. The specified WWF spacing was 6 inches.

**Figure 1:** Partial plan of the building showing the six (6) approximate core drilling locations (stars) (cropped plan courtesy of SCNA).

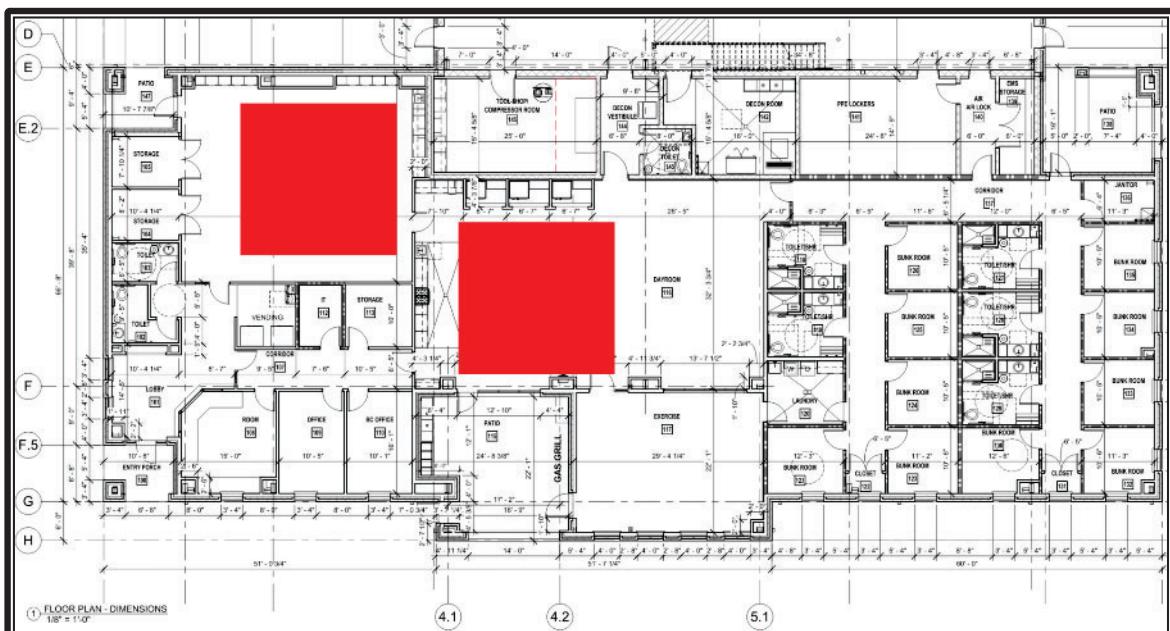
4. At the training room, the maximum elevation difference between any of the 36 measured locations was 0.84 inches.
5. At the dayroom, the maximum elevation difference between any of the 36 measured locations was 0.96 inches.
6. At the mezzanine, the maximum elevation difference between any of the 20 measured locations was 1.08 inches.
7. Significant irregularities in the concrete slab surfaces at any of the three (3) reviewed areas were not visually observed.

**Figure 2:** Partial plan of the building showing the approximate location of the two (2) levelness and flatness testing areas at the living area slab-on-ground (shaded) (cropped plan courtesy of SCNA).

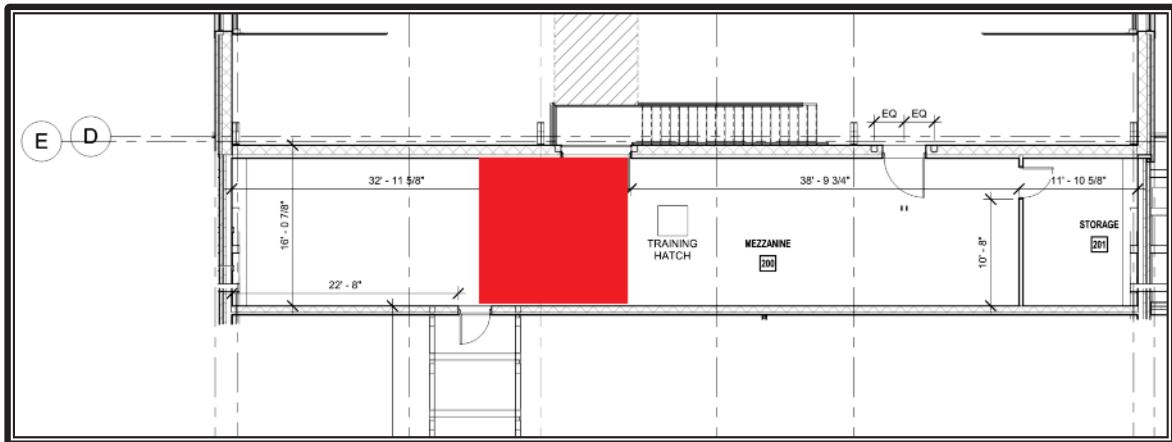
**Figure 3:** Partial plan of the building showing the approximate location of the one (1) levelness and flatness testing area at the mezzanine elevated slab (shaded) (cropped plan courtesy of SCNA).

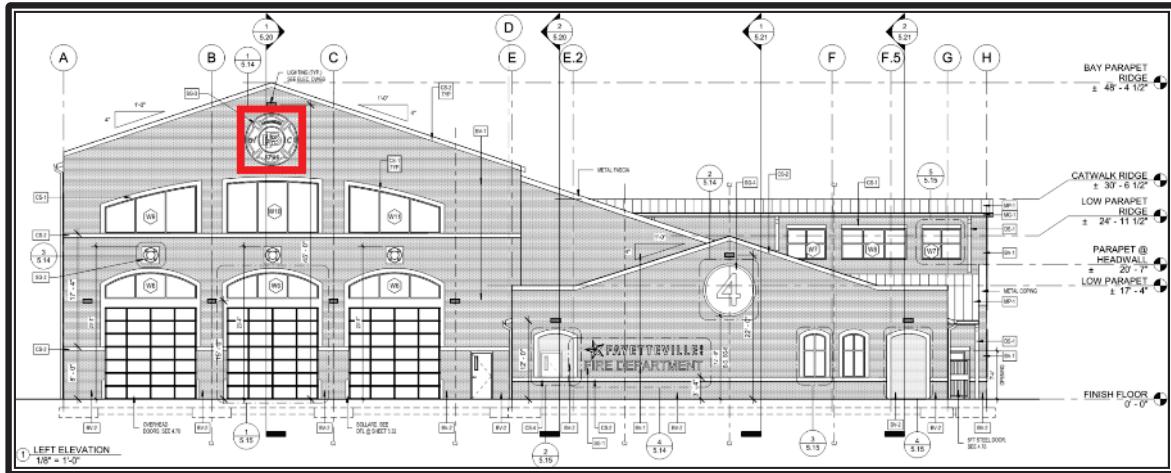
Test Area 1 was located at the large medallion on the west elevation of the apparatus bay above the bay door openings (**Figure 10**). In total, two (2) large medallions were installed at the exterior of the building. Investigation at Test Area 1 served as a representative sample of the construction

**Figure 10:** West exterior wall elevation showing the approximate location of Test Area 1 (outlined) (cropped plan courtesy of SCNA).

If the anchoring of the sector sections depicted on the shop drawings was used for installation of the ring sections at Test Area 1, missing anchors were identified. Due to the limited access and visibility, all anchors could not be identified; however, ABS was able to confirm that no anchors were installed along the bottom and outer edge of the lower ring section. The equivalent sector section from the shop drawings requires three anchors along this edge. It is ABS' opinion that the anchoring of at least one (1) section of the large cast stone medallions is not in compliance with the exterior cast stone shop drawings.

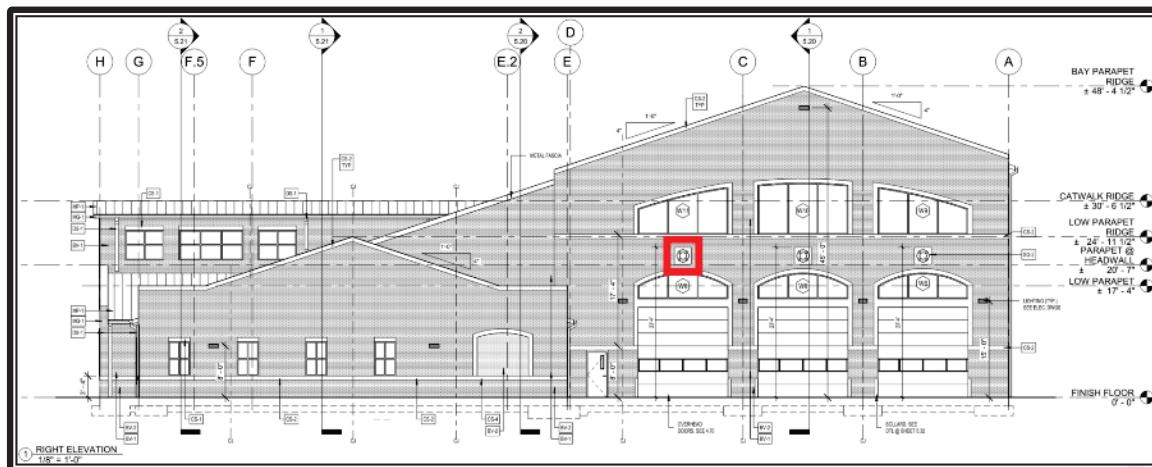
Test Area 2 was located at the southernmost small medallion on the east elevation of the apparatus bay (**Figure 11**). In total, nine (9) small medallions were installed at the exterior of the building. Investigation at Test Area 2 served as a representative sample of the construction of the small medallions. ABS removed five (5) full or partial brick veneer units located around the top, bottom, or right edge of the small cast stone medallion.

**Figure 11:** East exterior wall elevation showing the approximate location of Test Area 2 (outlined) (cropped plan courtesy of SCNA).

38. The cast stone medallion at Test Area 2 was comprised of a single rectangular section of cast stone.

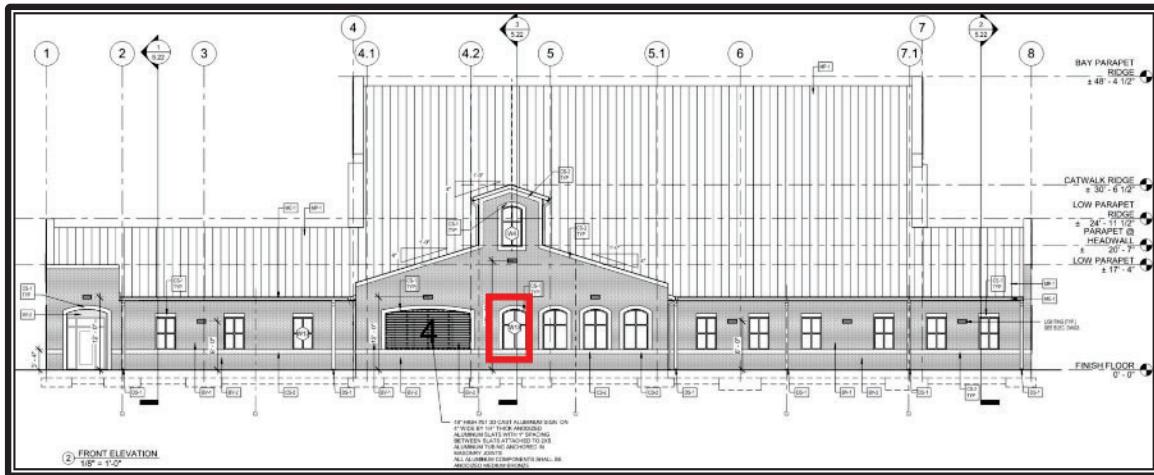
Test Area 3 was located around the window opening at the south elevation of the living area (**Figure 12**). The test area included cast stone accents at the head and jambs of the window opening as well as the water table along the elevation of the brick veneer wall. ABS removed three (3) full brick veneer units located around the cast stone accents.

Figure 12: South exterior wall elevation showing the approximate location of Test Area 3 (outlined) (cropped plan courtesy of SCNA).

42. The cast stone accents at the jamb of the window were comprised of multiple sections of cast stone.
43. At the joint between sections of cast stone along the jamb of the window opening, an anchor was observed. The depth of the anchor flange into the cast stone could not be determined.
44. At the joint between the cast stone at the top of the jamb and the head of the window opening, no anchor was observed.
45. At the top edge of the cast stone along the head of the window, masonry wall ties were observed at each of the intersecting metal studs (**Photo 9**).
46. At the cast stone water table, masonry wall ties were observed along the top and bottom of the stone at each of the intersecting metal studs.

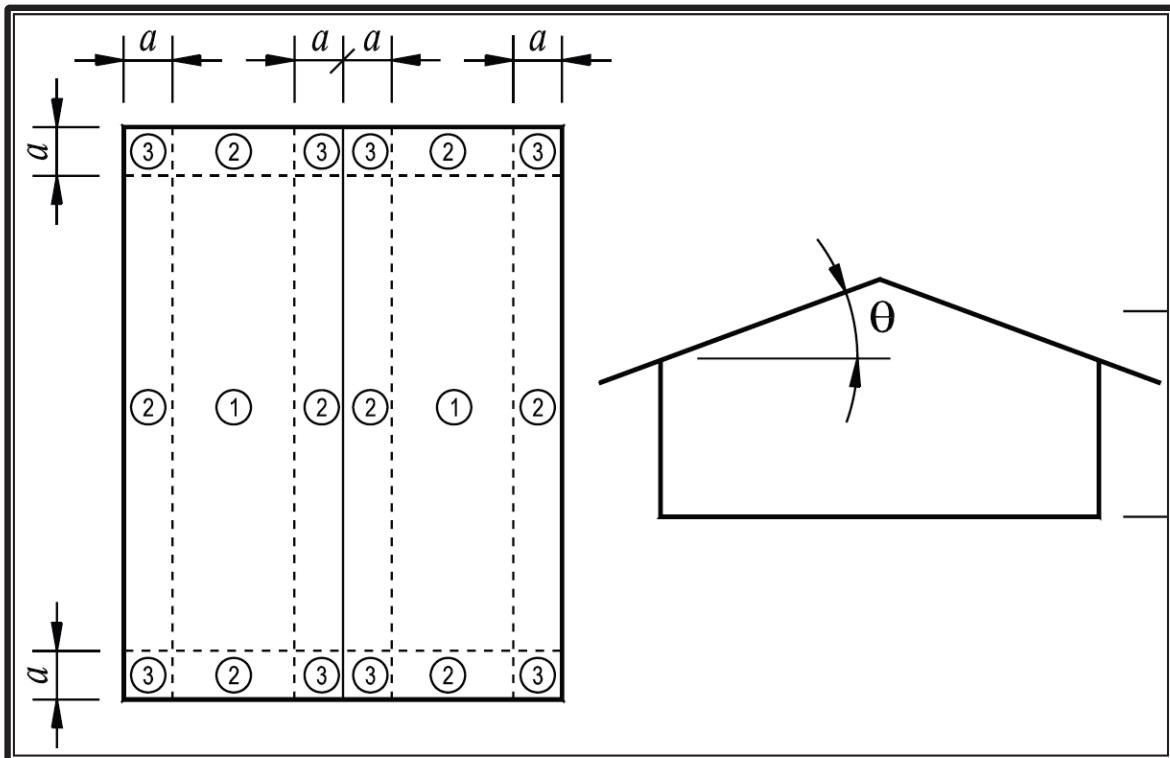
For a view of the zones referenced in the plans (Sheet 3.00), see the diagram from ASCE 7-10 (**Figure 13**).

Figure 13: Wind pressure zones for gable roofs with a slope between 7° and 27° (courtesy of ASCE 7-10).
