**Item Title:** Post Incident Review Program Update

# Wake County Post Incident Review

# Post Incident Review Report

House Fire with Fatality  
1108 Leach Street  
Raleigh, NC 27603  
Incident 11-0015384

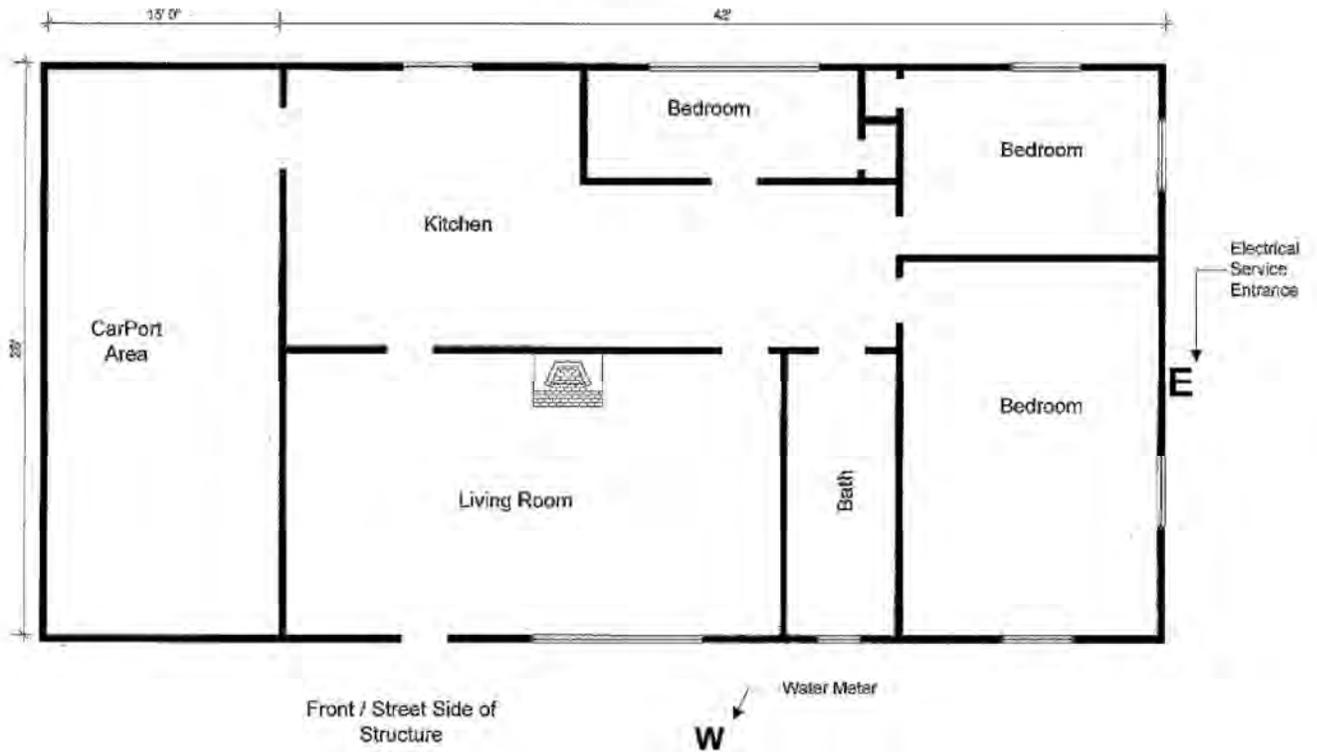
# Drawing 1<sup>st</sup> Floor

WCFM Case # 12-09547  
128 Bridge Street  
Fuquay-Varina NC 27526  
1<sup>st</sup> Floor Sketch  
Drawn by: D. Braxton

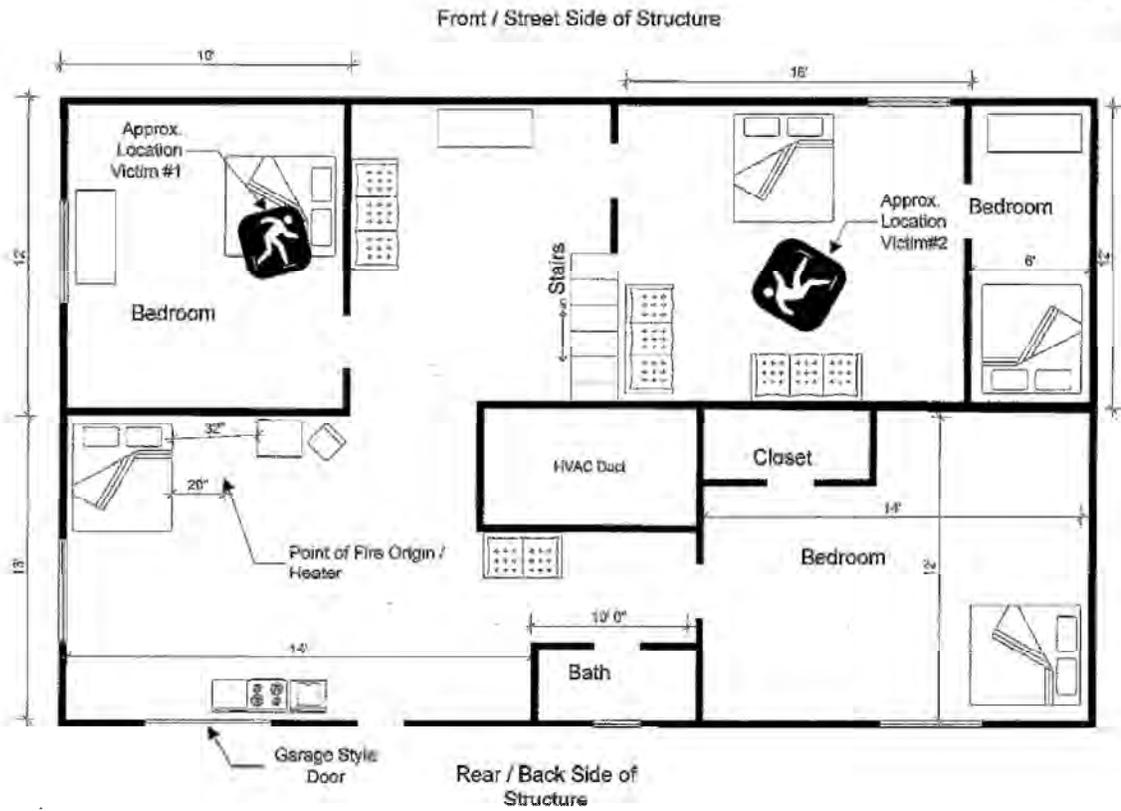
# Drawing of Basement

WCFM 12-09547  
128 Bridge Street  
Fuquay-Varina NC 27526  
Basement Area Detail Diagram & Sketch  
Drawn by: D. Braxton
