Pine Knoll Townes Fire

Created by Mike Legeros

Looking Back:

Pine Knoll Townes; Raleigh, N.C.

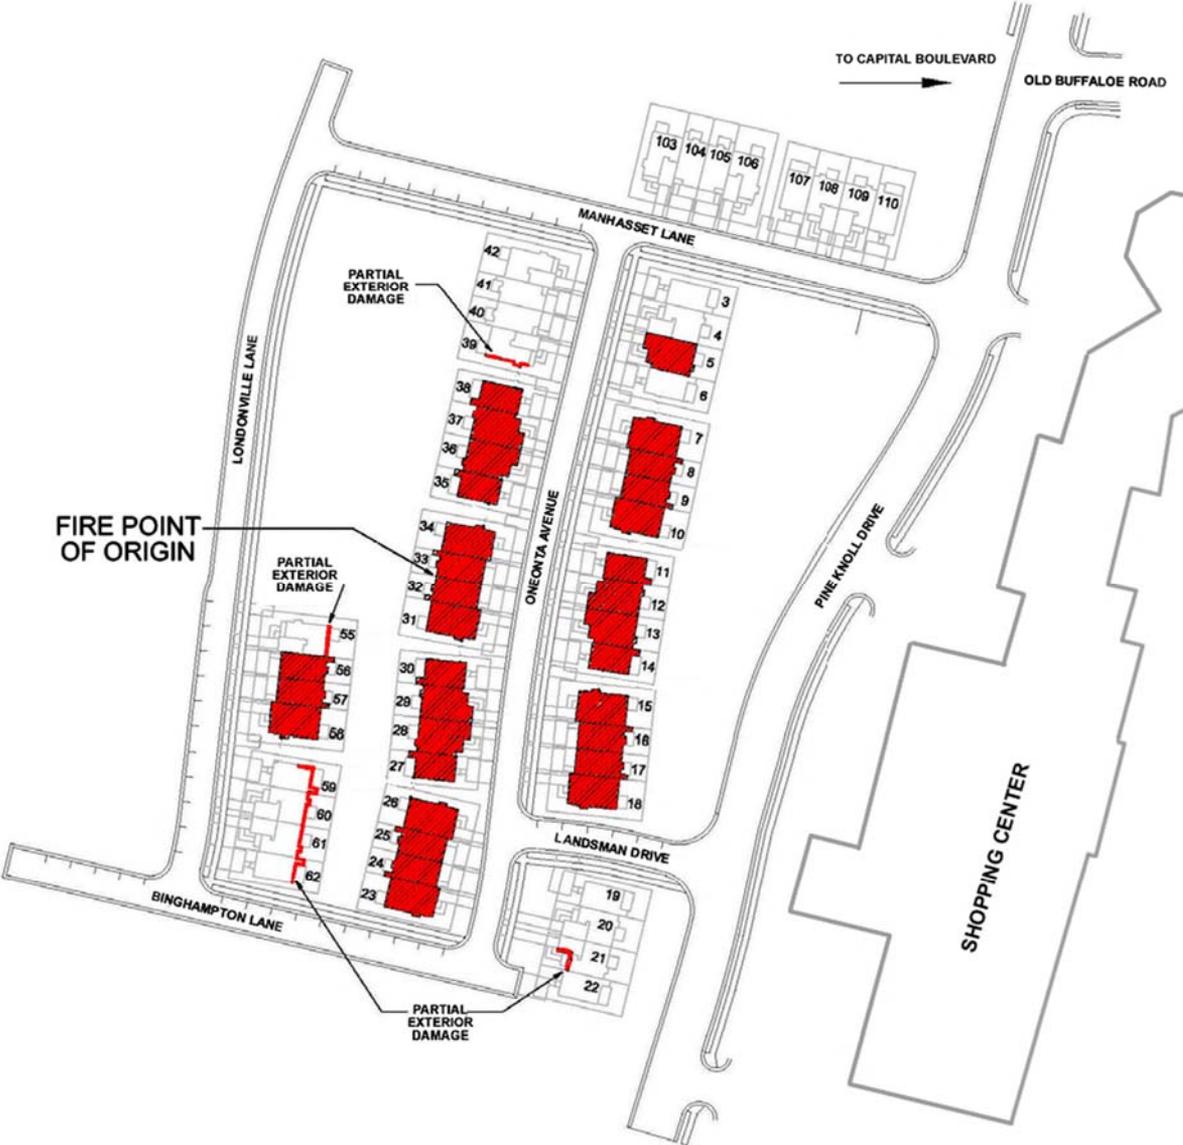
Site Diagram

The main street, Oneonta Avenue, ran north-south, with five buildings on each side. Their vinyl siding extended to the ground; their lawns were covered with pine straw. The buildings were 16 to 19 feet apart.

At 3:03 p.m., a brush fire was reported at 3535 Oneonta Avenue, the middle building on the west side. Second-due Engine 27 was dispatched.

Pine straw was burning on Oneonta, and flames spread to the building. Embers also started fires at two other buildings, which callers reported at 3:05 p.m.

Continuing south, he saw multiple buildings burning on Oneonta. Most of the fire was on the west side of the street, but roof lines were also catching on the east side. Grass fires were also burning up to the east-side buildings.

The first arriving ladder was deployed on Pine Knoll Drive, between the buildings facing east on Oneonta and the rear of a shopping center facing Capital Boulevard.

On the south end of Oneonta, crews concentrated on protecting the last building on the east side. Engine 22 pumped to Ladder 22, operating a reserve platform.

On the south end of Londonville Lane, one block west, two buildings had caught fire. Ladder 26 was already there, directing its stream onto Oneonta. Aerial operations were stopped, and lines were brought into both buildings. Most of the units were saved.
